ABC Home Inspections  
**Home Inspection Report**  
**Confidential**

Prepared exclusively for  
87 Nelson St, Vancouver, BC

Property Address: 87 Nelson St, Vancouver, BC  
Date of home inspection: Thursday, July 25, 2024  
Inspection start time: 10:00 AM  
Inspection end time: 12:15 AM  
MLS#: not available  
Year Built: 2019  
Construction: Concrete / Metal  
Furnished: No  
Occupied: No  
Floor Area Total: 534 sq. Ft.

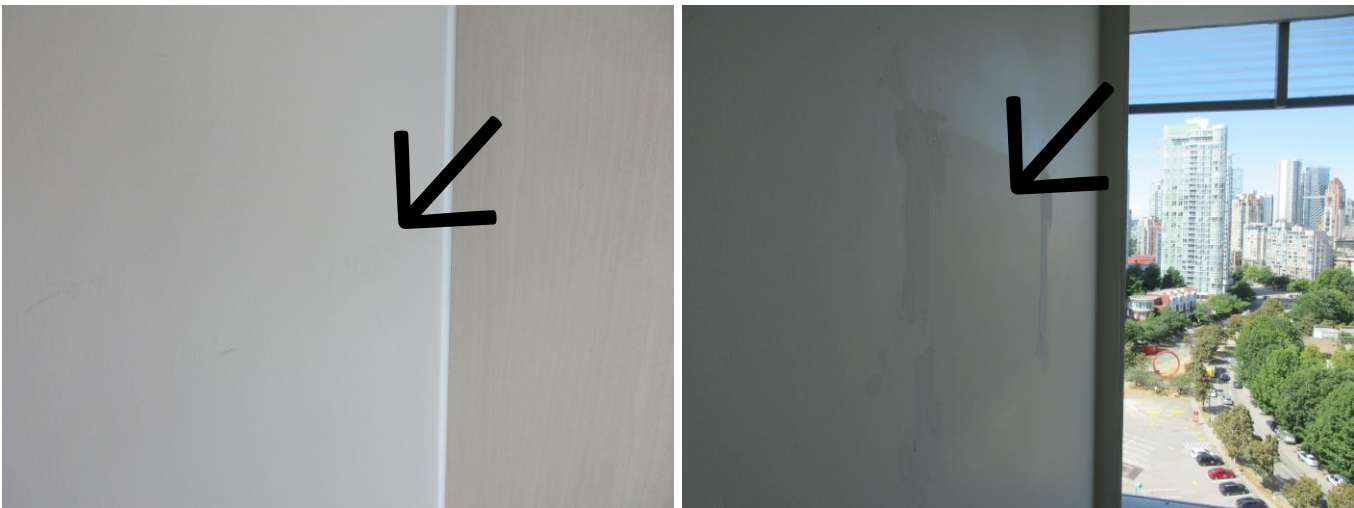
The wall paint was damaged, and missed, on the living room wall. It is likely to be cosmetic issue. I recommend re-painting the wall.

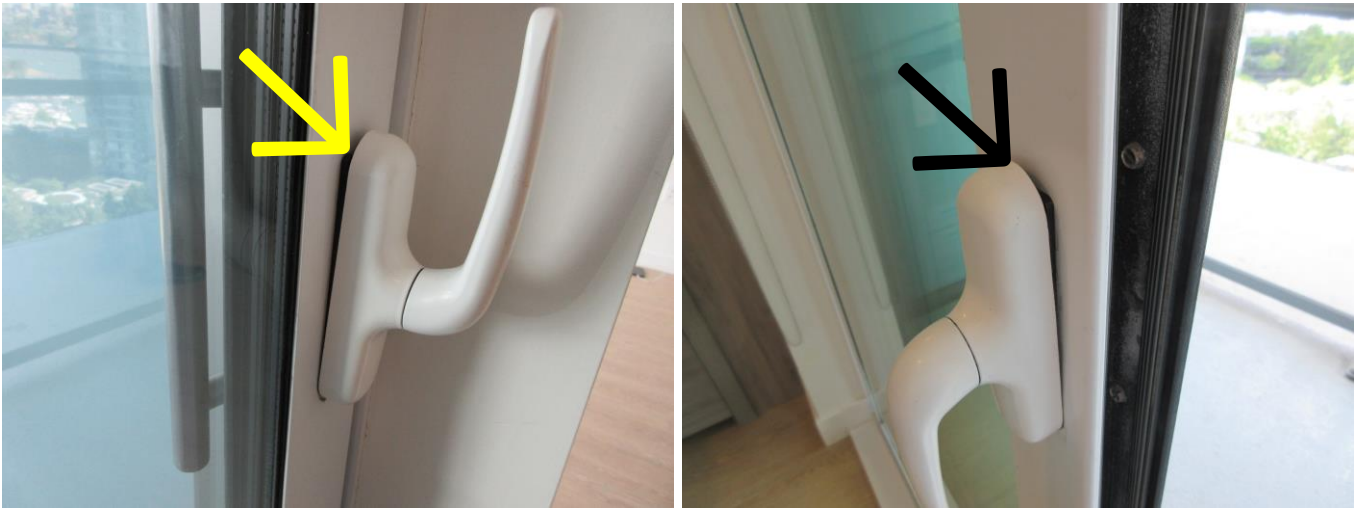
The balcony had the aluminum door type. The door handle was loose. Fixing the handle door is recommended.

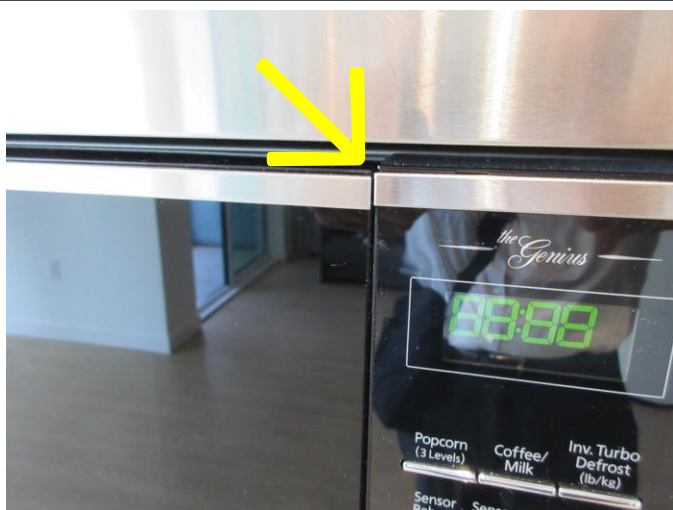
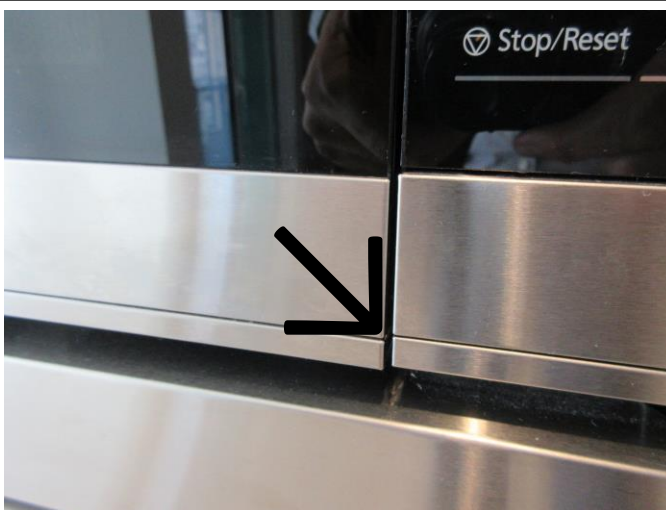
The microwave door was not even and match with the round panel. The door showed minor drop down. It is likely to be cosmetic issue.

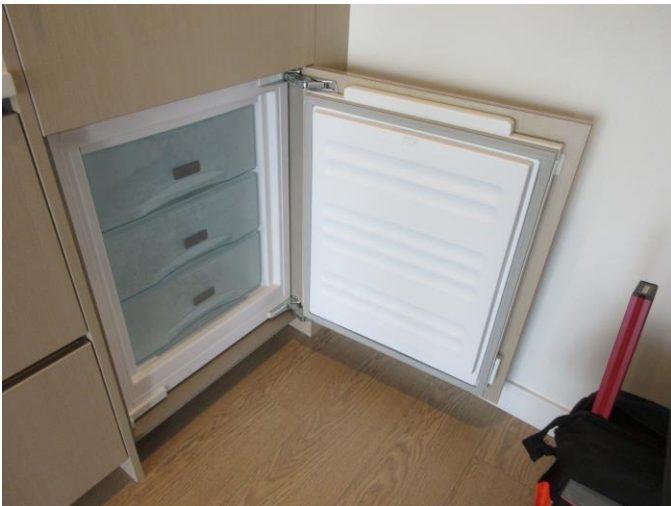
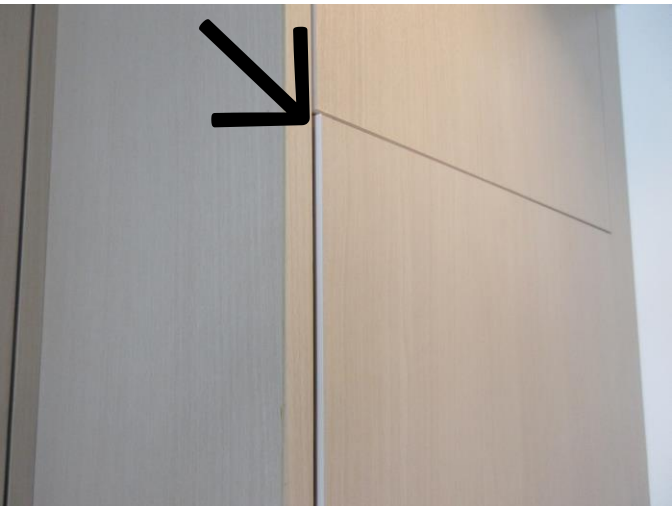
The door of fridge and freezer was not even with the left cabinet panel. It is likely to be cosmetic issue.
