ABC Home Inspections  
**Home Inspection Report**  
**Confidential**

Property Address: Surrey, BC  
 Date of home inspection: Tuesday, September 6, 2022  
 Inspection start time: 5:00 PM  
 Inspection end time: 7:30 PM  
 Registration BC No: 12893  
 Manufacture model No (CSA): 364  
 MLS# not available  
 Year Built: 1972  
 Construction: -  
 Furnished: Yes  
 Occupied: Yes  
 Floor Area Total: 960 sq. Ft.

Style: Mobile\_home  
 Stories: 1  
 Orientation (Front Facing): North

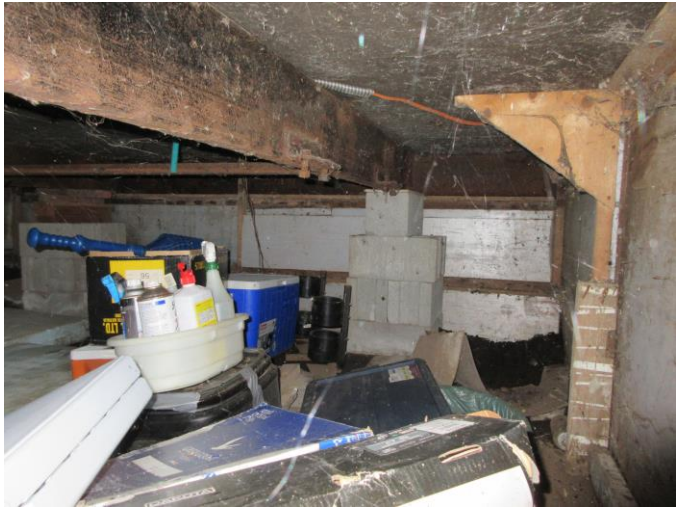
## 1.1 Foundation

The mobile house had base concrete foundation. The mobile house was not fasten to the ground. This is significant structure deficiency. I recommend contact a qualified contractor for further evaluation and fixing the issue.

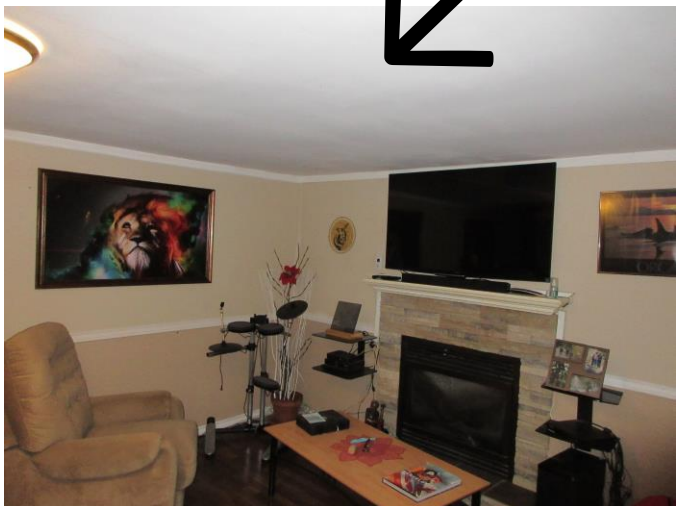
## 1.2 Ceiling

The ceiling sagged in the living room of the house. The ceiling sagging needs to be monitored for any changes, contacting a qualified contractor for more action.

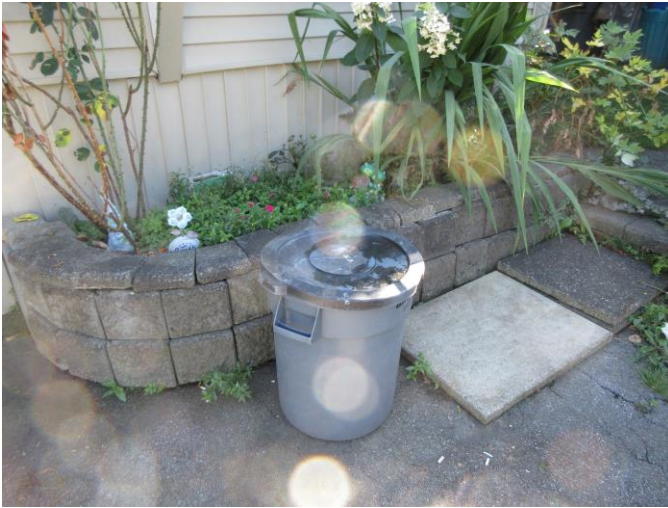
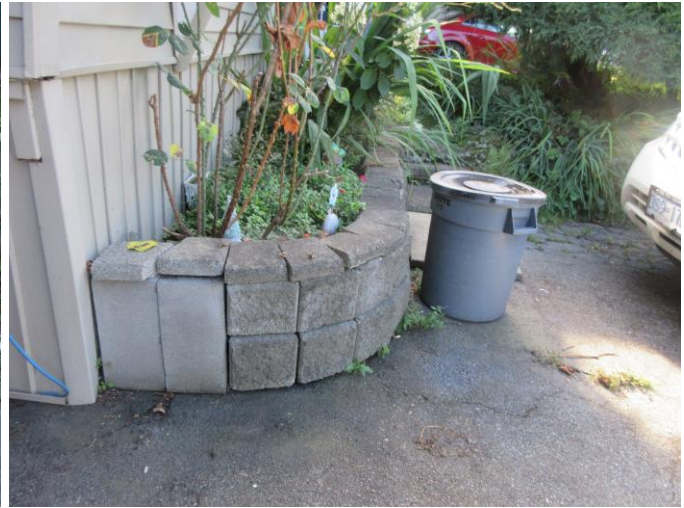
### 1.3 Retaining wall

The house had masonry stone retaining wall on the north side of the house. The uneven surfaces and moving blocks were founded on the retaining wall. Fixing the retaining wall is recommended.

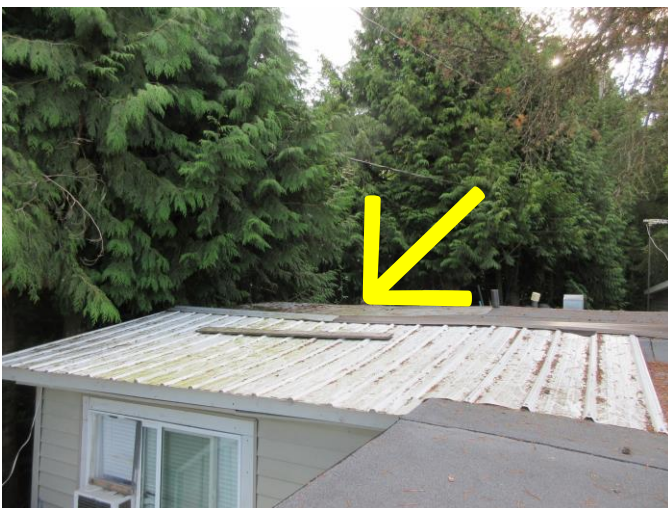
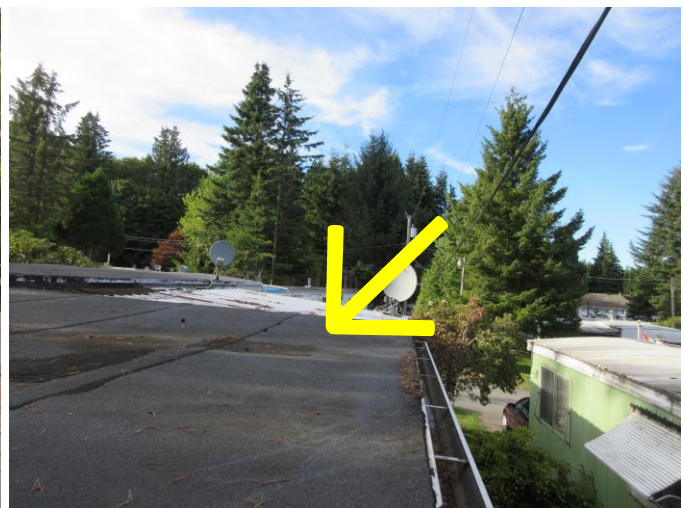
### 1.4 Roof

A significant sagging and wavy surface was noted on the roof. The sagging and wavy surface of the roof is the significant deficiency and indicate the potential of the moisture entering to the house. The sagging needs to be fixed, and maintained by the qualified contractor as recommended.

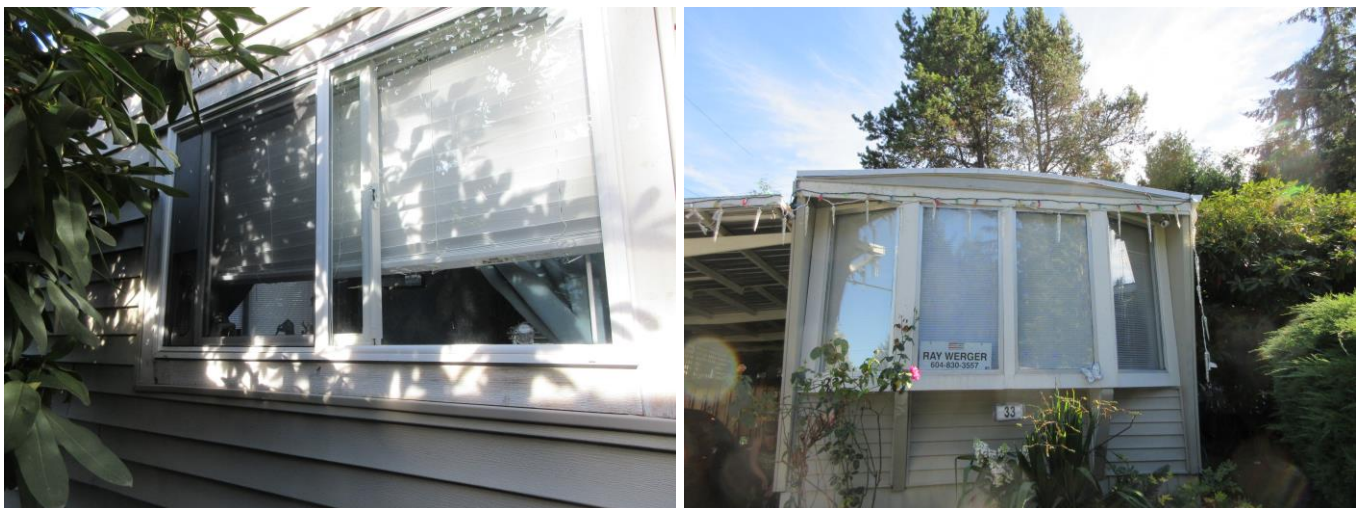
### 2.2 Window

The house had combination of vinyl and aluminum window type with double pane. It was functional with no deficiency at the time of this home inspection.

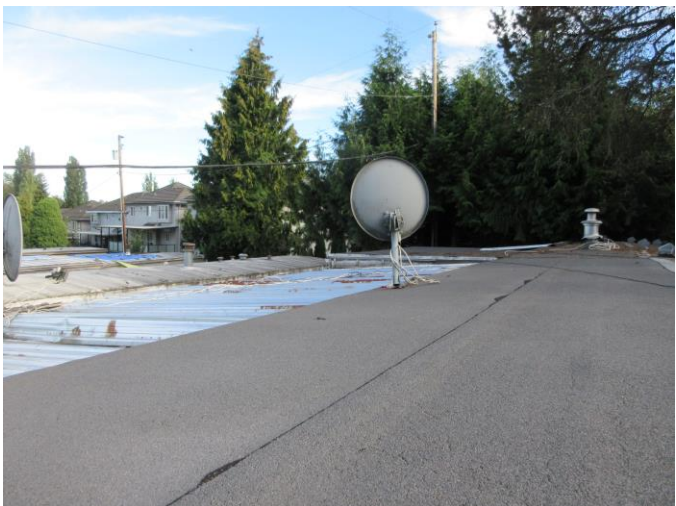
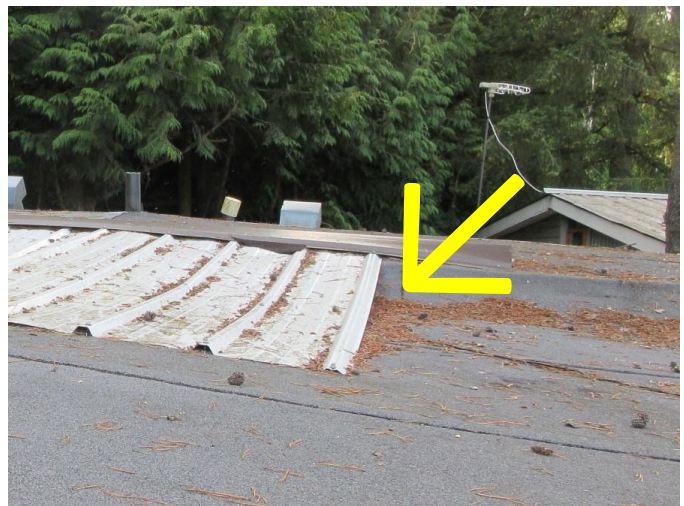
### 3.1 Roof Covering Material

The combination of the torch-on (asphalt rolling) and aluminum sheet were the coverage of roof. The cavity was noted on the connection point of asphalt rolling and aluminum sheet. Any cavity had the potential of the moisture entering to the house. It appears the best tradesman practice was not applied to the roof covering.

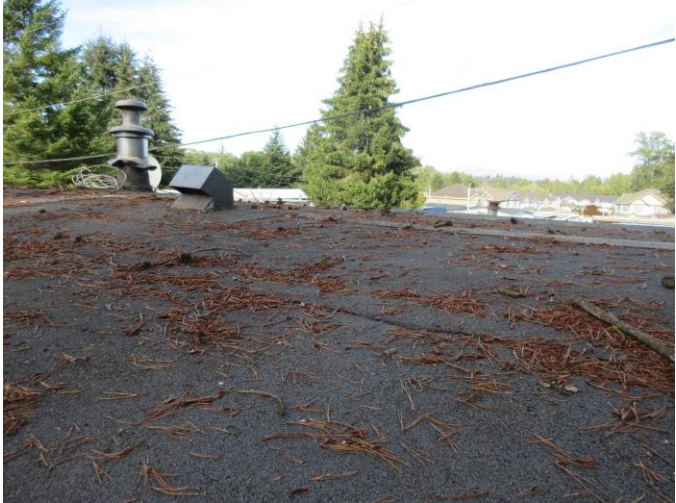
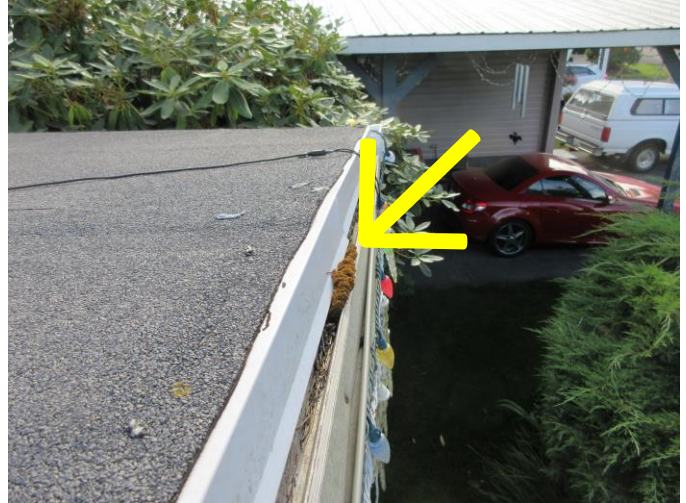
The tree leaves covered the roof surface of the house. Debris and tree leave cleaning around the roof is recommended.

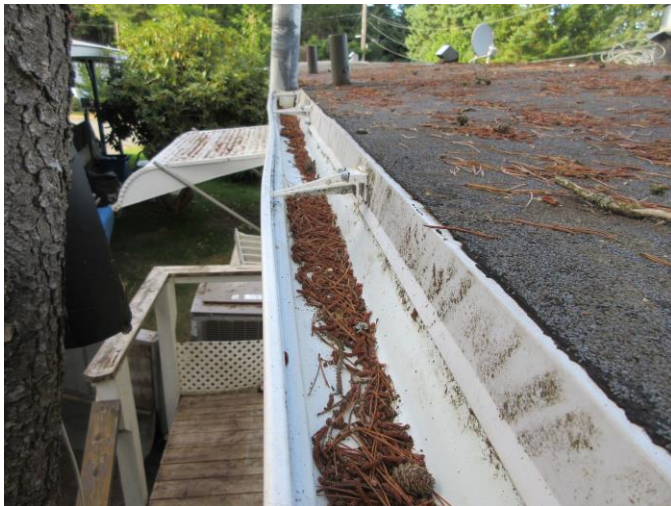
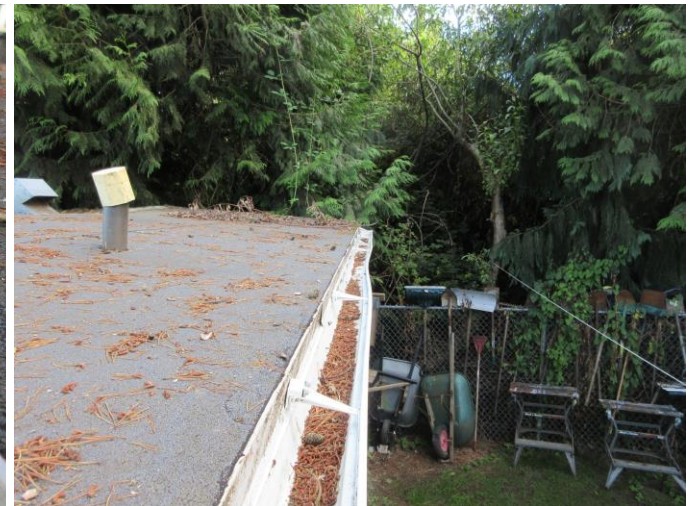
### 3.3 Gutter and Downspout

The debris and tree leaves were noted inside of the roof gutter. I recommend clean the gutter to prevent any water leakage to the house. Gutters that drain poorly or clogged can lead to many costly roof edge. It can also cause gutters to pull loose and lead to possible water intrusion.

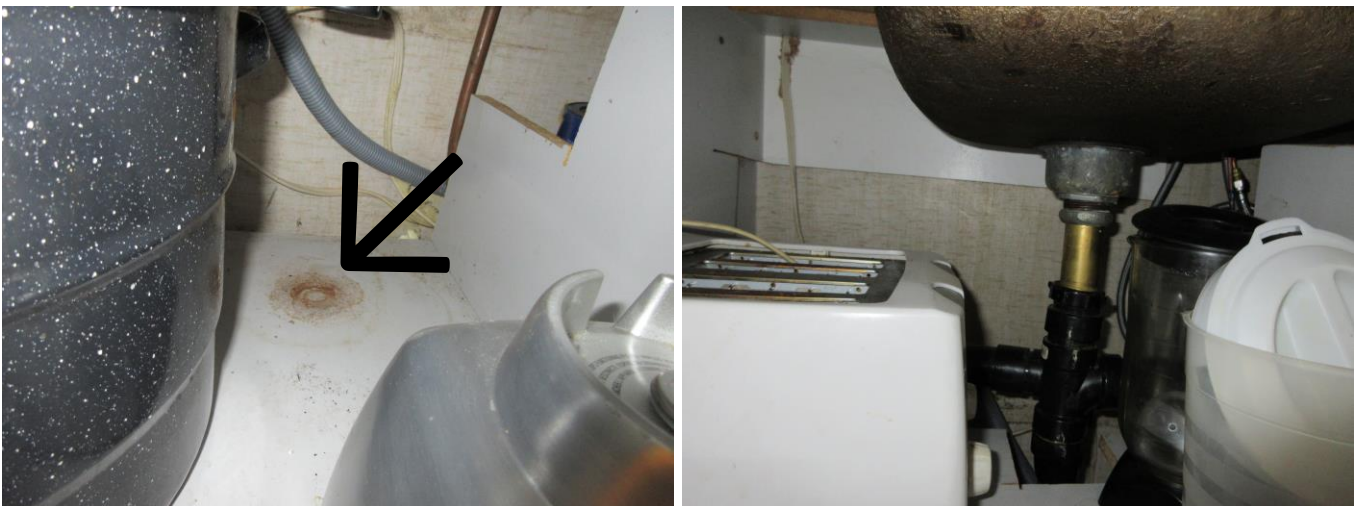
### 4.2 Kitchen and laundry sink & faucet

The water leakage was noted under the kitchen sink sewage pipe. I recommend fixing the water leakage.

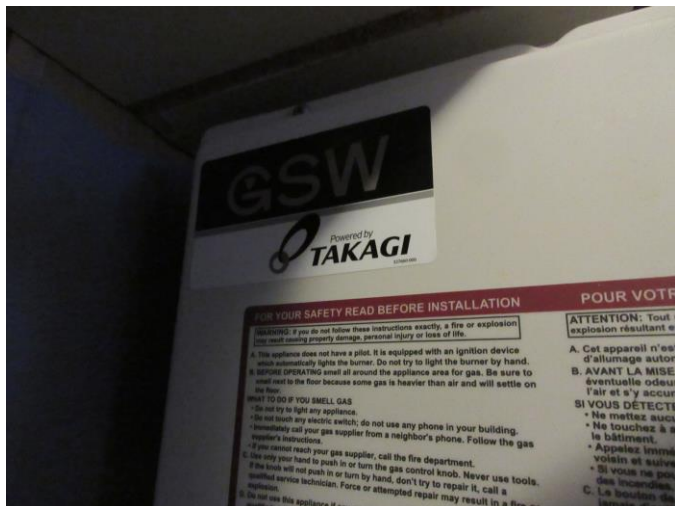
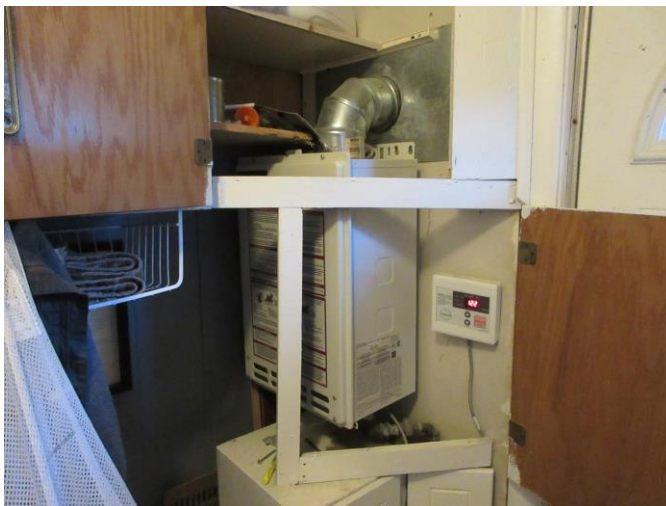
## 4.3 Hot Water Tank

The tank less water heater was manufactured dated 2019. The tankless water heater life expectancy is more than 20 years. It has no leaks and is functioning well at the time of this home inspection.

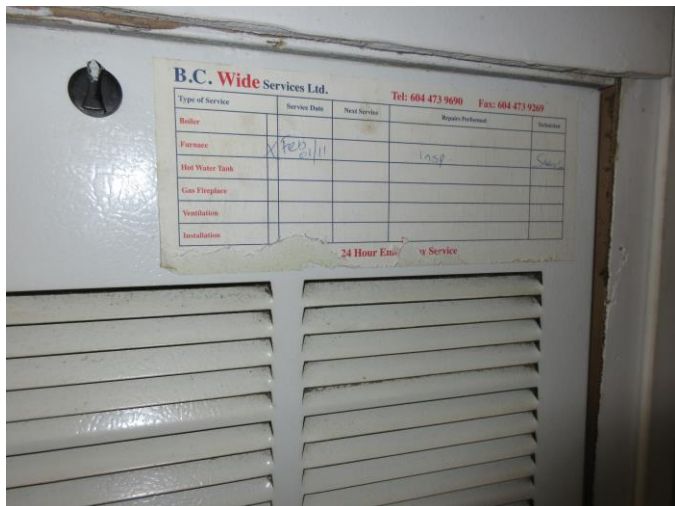
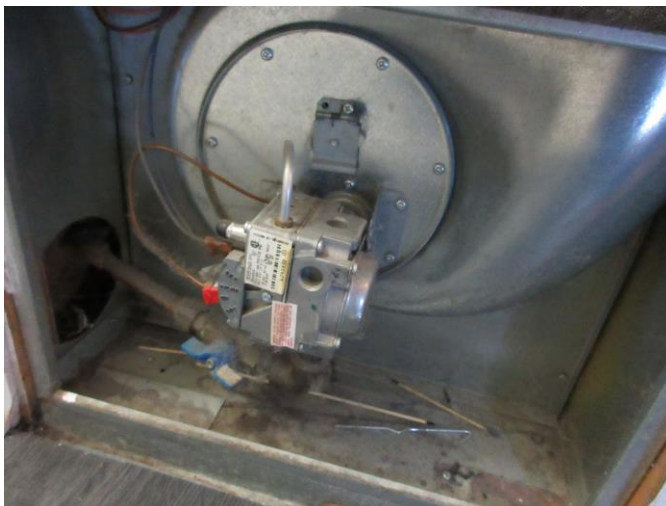
### 5.1 Furnace

The furnace was a mid-efficiency type with input 40000 BTU. The furnace manufactured in dated 2003. The furnace life expectancy is 15-20 years. The Furnace is 19 years old and has passed its expected service life. Expect to replace the furnace. However, the furnace was functional with no deficiency at the time of this inspection.

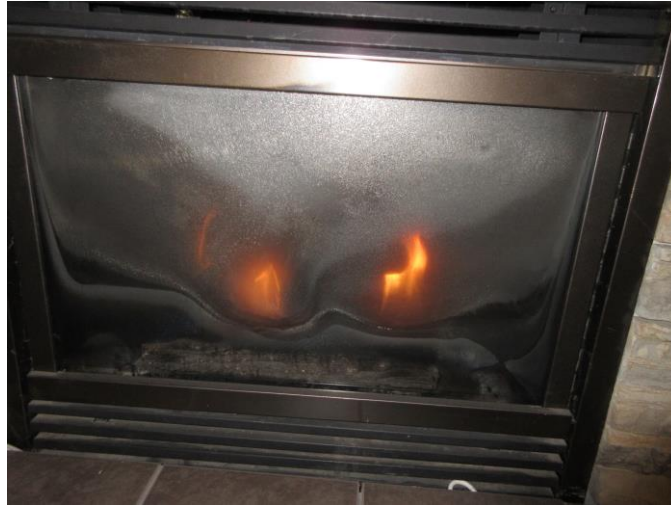
## 5.2 Fireplace

The house had gas fireplace type. The fireplace had the smoke glass. Cleaning the fireplace is recommended.

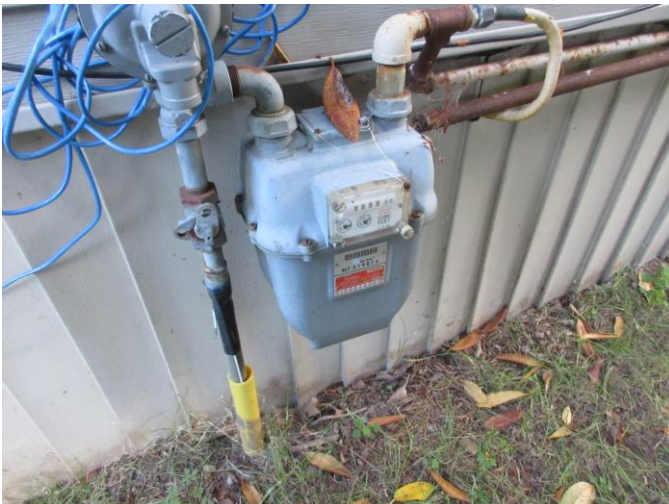
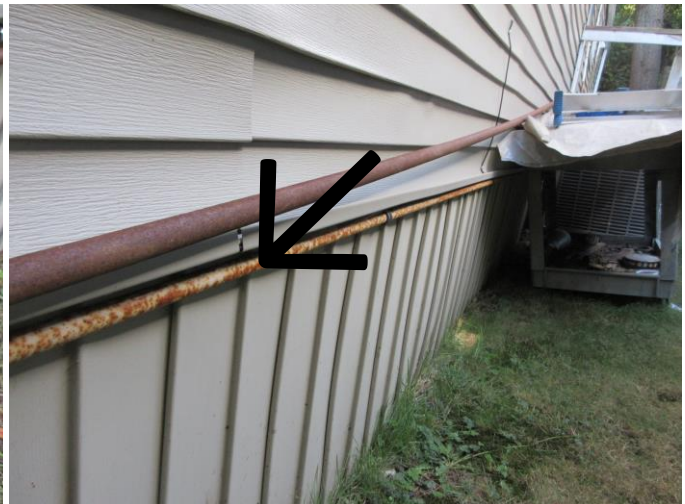
## 5.3 Natural Gas

The natural gas meter was located on the west side of the house. The natural gas meter pipe was rusted. I recommend fixing and repainting the gas meter pipe.

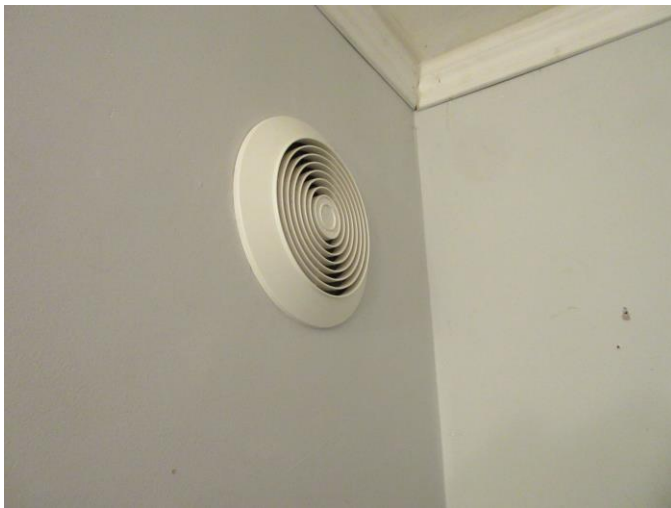
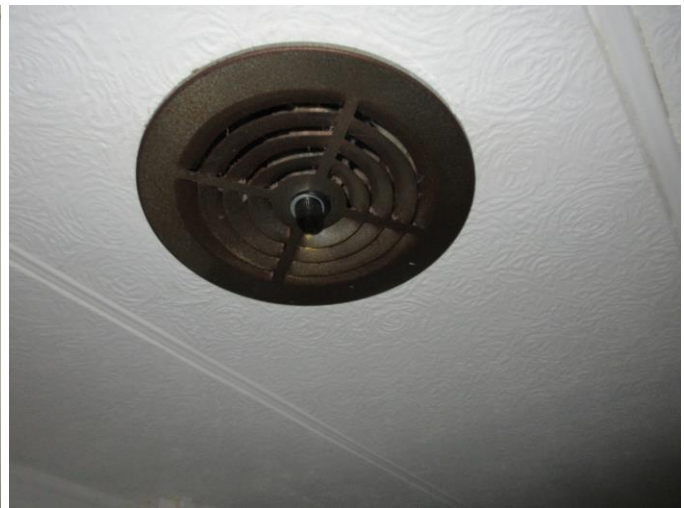
### 7.1 Bathroom & Washroom

There were electrical exhaust fans in the bathroom and the washroom of the house. The exhaust fan in the master washroom and main bathroom were functional with no deficiency at the time of this home inspection.

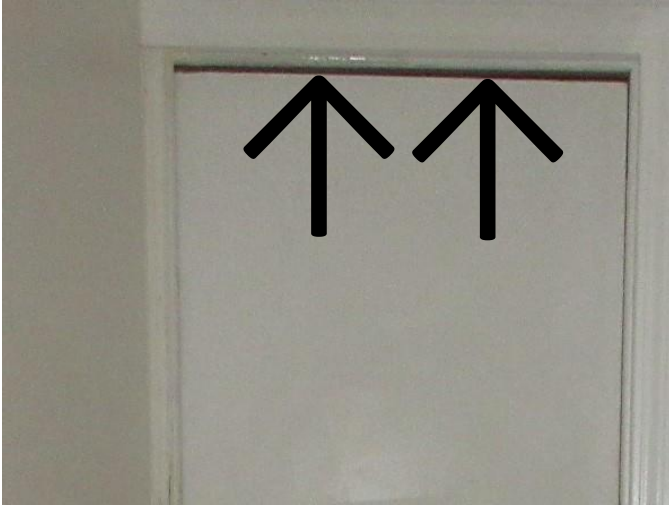
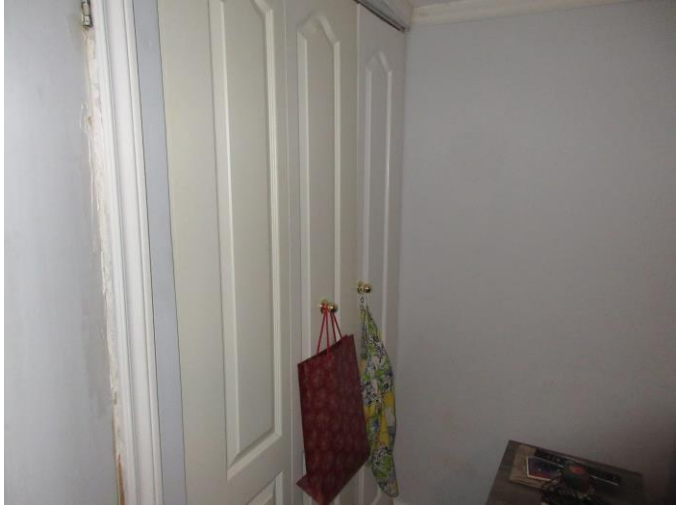
## 8.2 Door & Closet door

The cavity was noted on the top of the master bedroom door. Fixing the door is recommended. The house had vinyl door type for the closets. The closet doors, and hardware were functioning and likely perfect with no deficiency at the time of this home inspection.

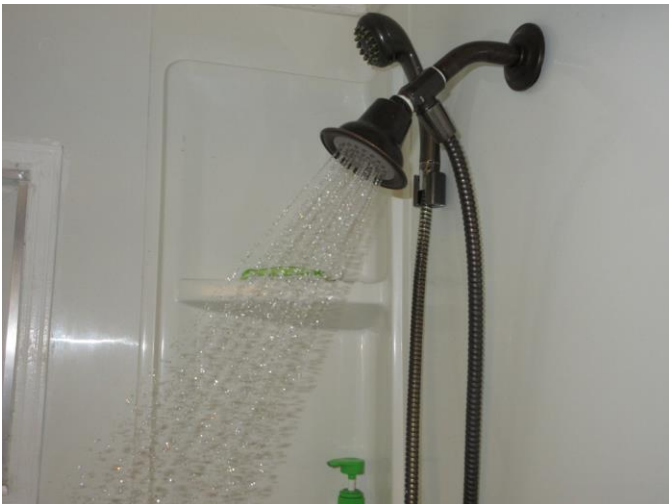
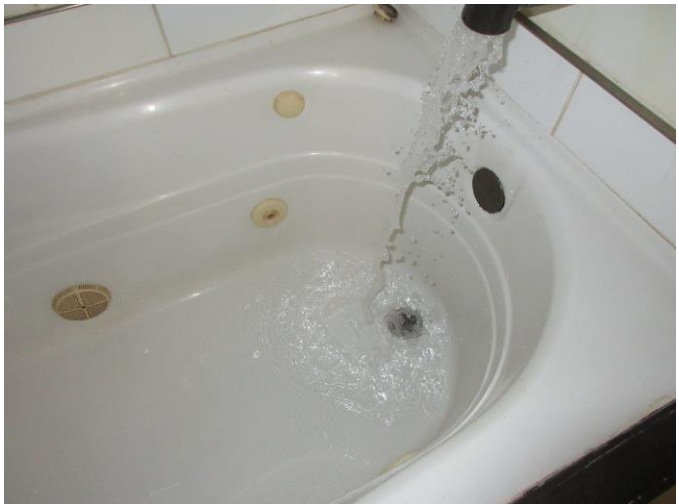
## 8.3 Bathtub

The bathtub, faucet, and shower were functional. It seemed well with no deficiency at the time of this home inspection.

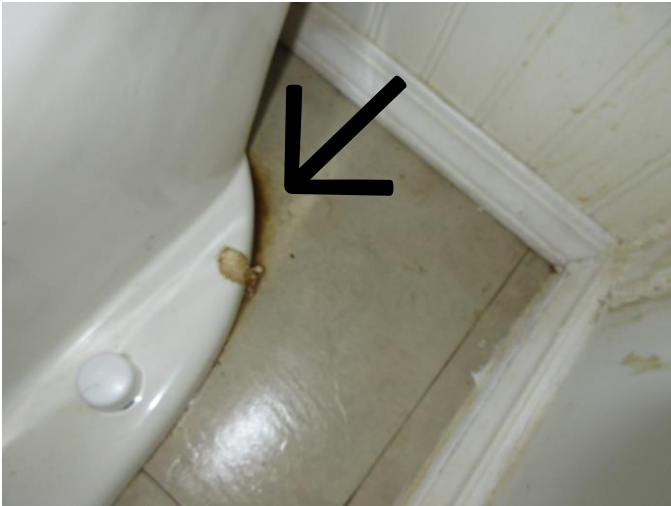
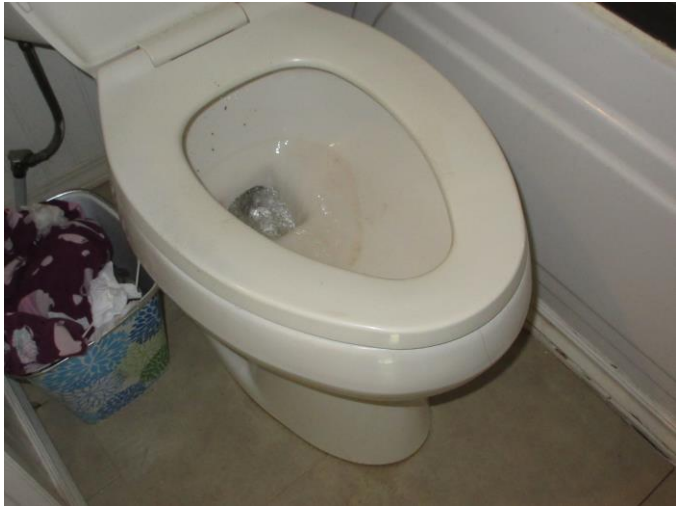
## 8.4 Washroom

The water leakage was observed at the back of the toilet in the bathroom of the house. I recommend fixing the water leakage by a qualified contractor.

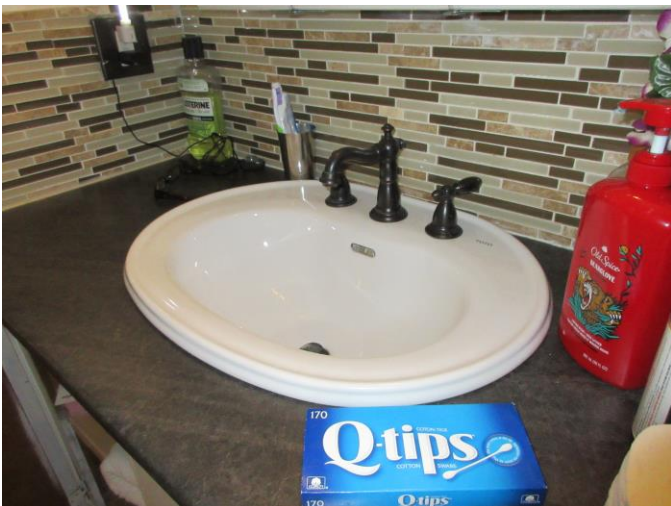
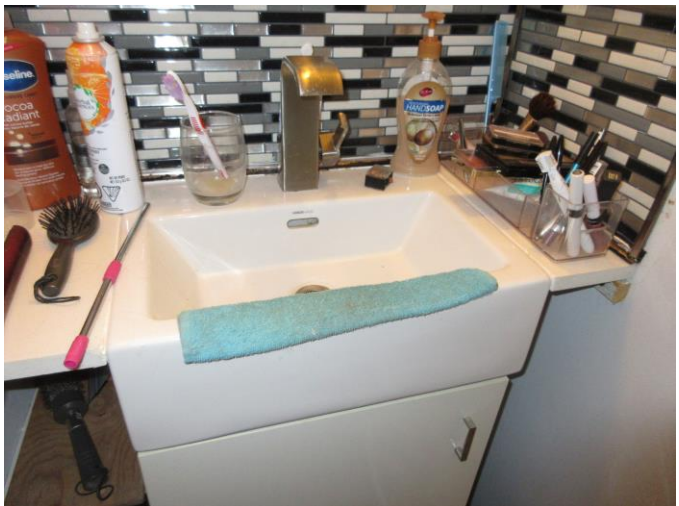
All basins and faucets were tested in the master washroom and main bathroom of the house. The basin bowl was secure and faucet was functioning with no deficiency and at the time of this home inspection. Water fixture seemed to be in satisfactory condition at the time of this home inspection.

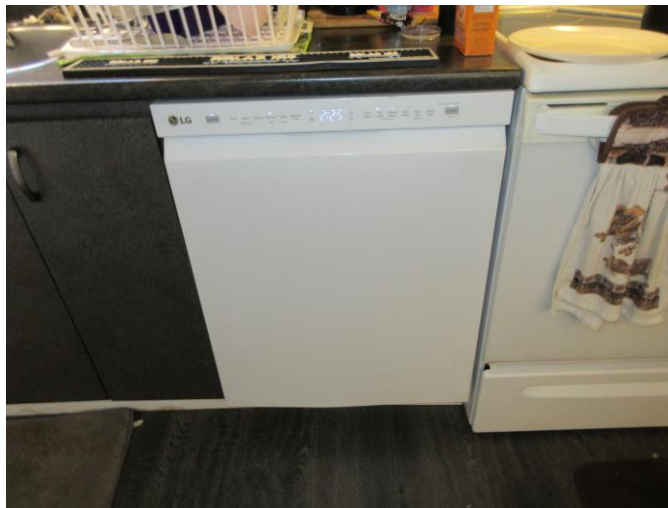
## 8.6 Dishwasher

The dishwasher was tested. It was likely perfect with no water leakage at the time of this home inspection.

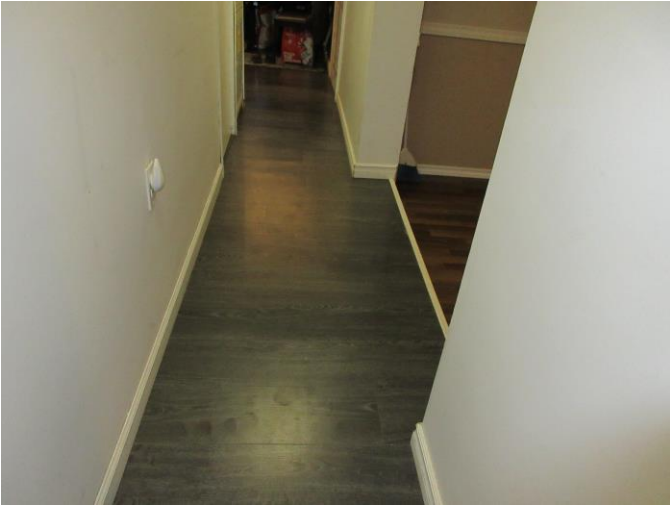
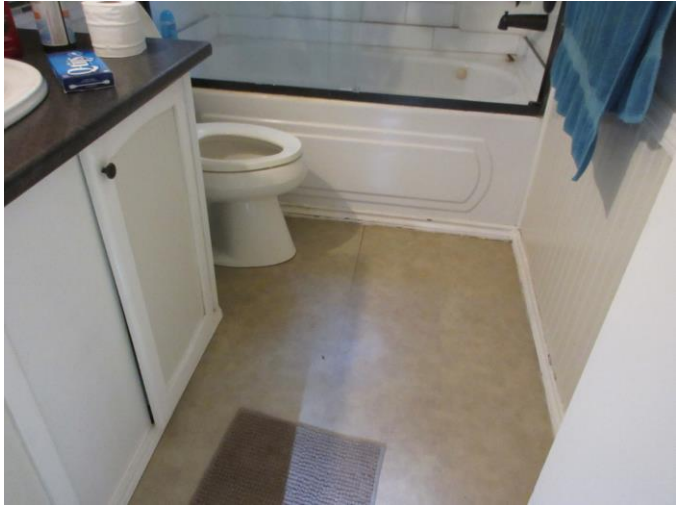
## 8.7 Floor cover

The house floor was covered laminate, and linoleum. It was likely perfect with no deficiency at the time of this home inspection.

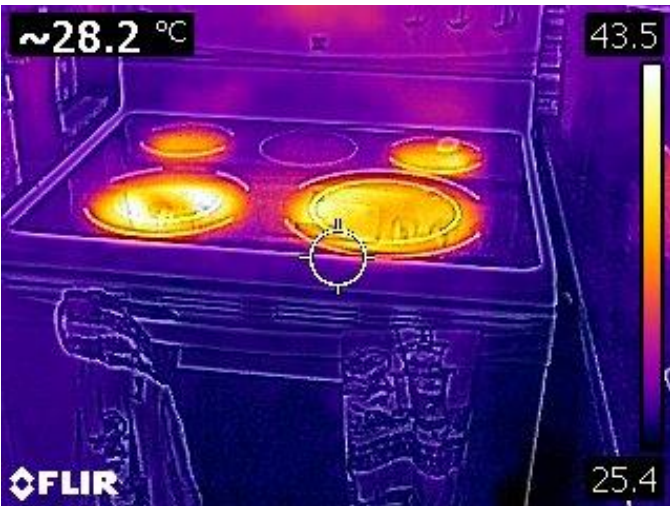
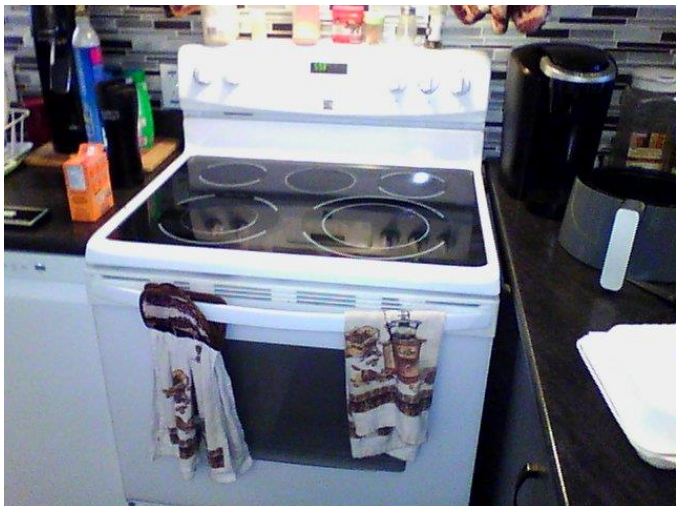
## 8.8 Stove & Oven

The house had electrical range type. The electrical range was tested and was functional at the time of this home inspection.
