ABC Home Inspections

Home Inspection Report

Prepared exclusively for
Maple Ridge, BC

Property Address: Maple Ridge, BC
 Date of home inspection: Thursday, May 23, 2024
 Inspection start time: 10:00 AM
 Inspection end time: 1:30 PM
 MLS#: not available
 Year Built: 2011
 Construction: -
 Furnished: Yes
 Occupied: Yes
 Floor Area Total: 2862 sq. Ft.

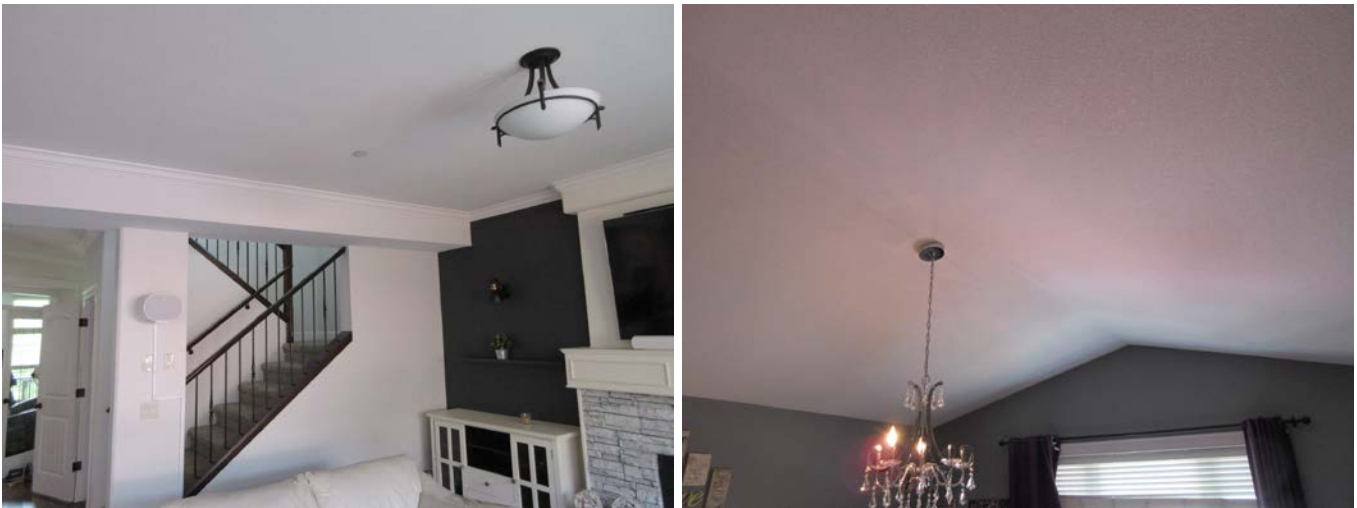
1.1 Main

The house had wood floor, dry board ceiling and drywalls. The interior walls, ceilings, and floors show no defects or structural deficiency at the time of this home inspection.

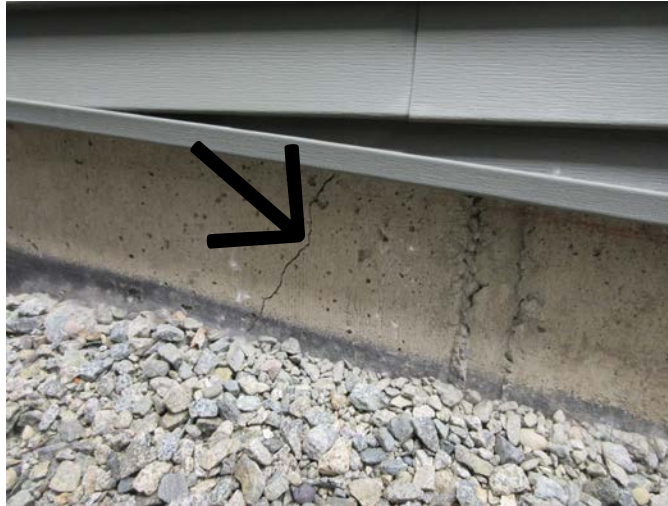
1.2 Foundation Wall

A crack was observed on the foundation wall on the south side of the house. It was 2 mm wide crack. Every crack or opening in the foundation wall is a potential source for moisture entry. The crack needs to be monitor for any changes contacting a qualified contractor for more action.

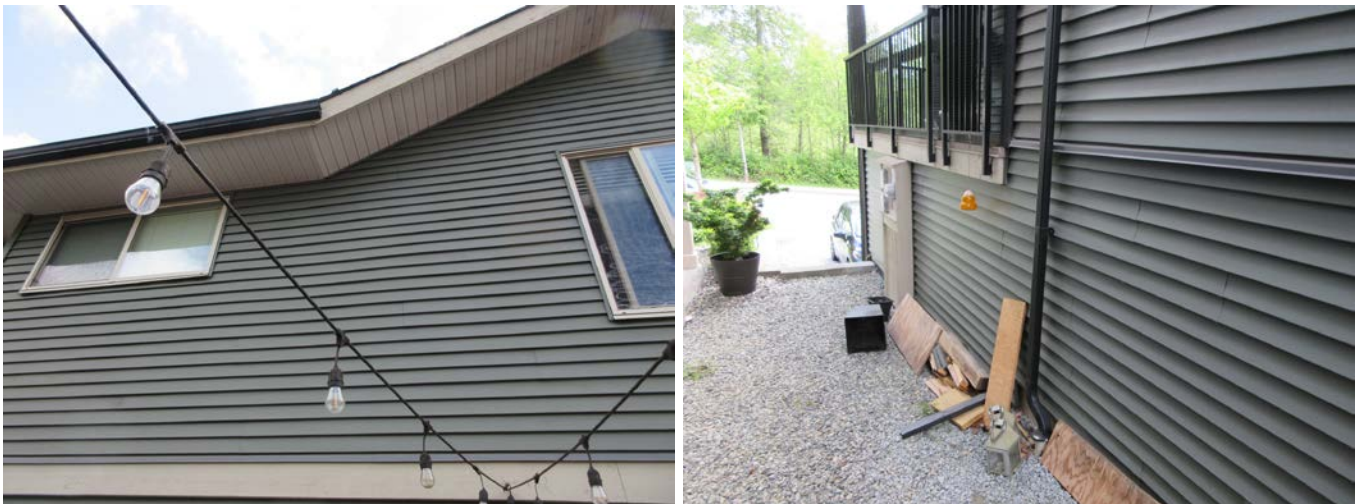
2.1 Wall Cladding

The house exterior wall had vinyl siding. The vinyl siding was functional with no deficiency at the time of this home inspection.

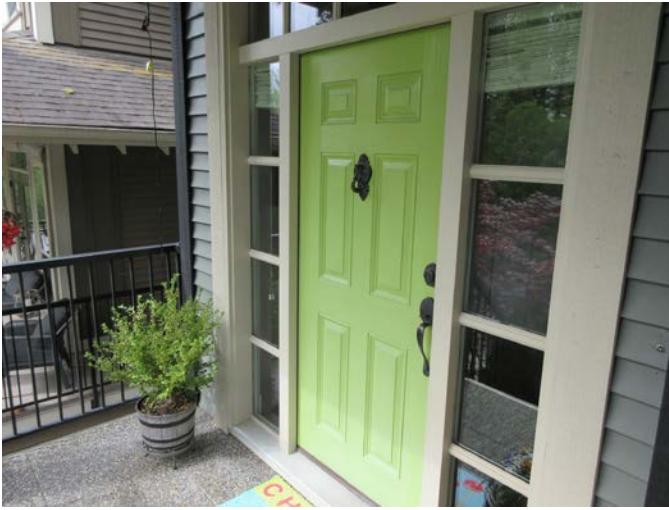
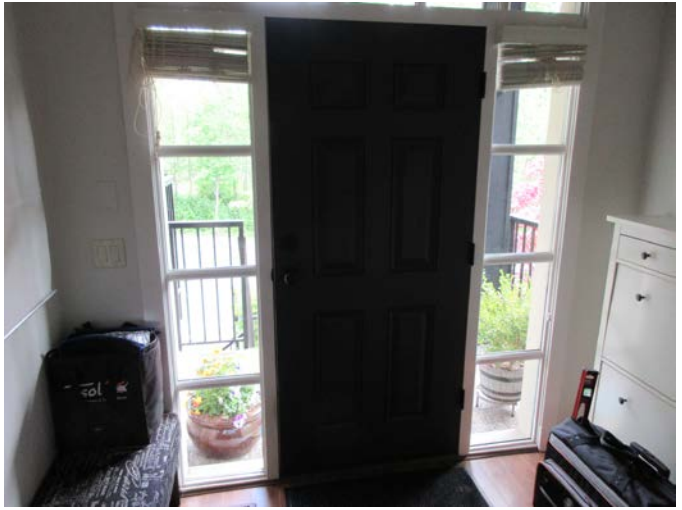
2.2 Exterior Door

The house had wood type main entrance door. The main entrance door of the house seems to functioning with no deficiency at the time of this home inspection.

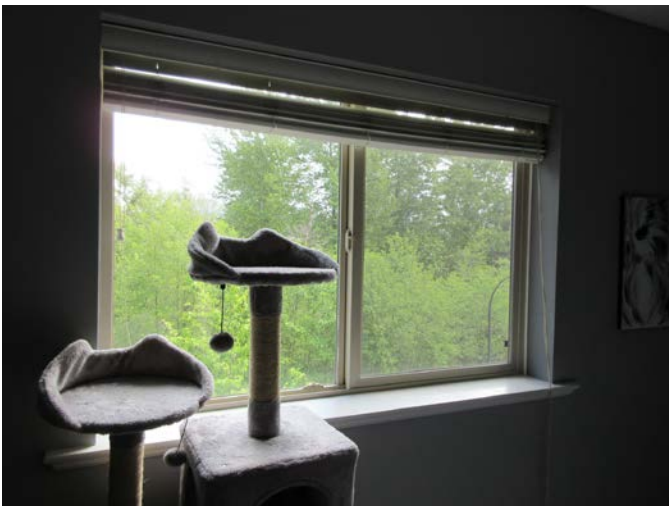
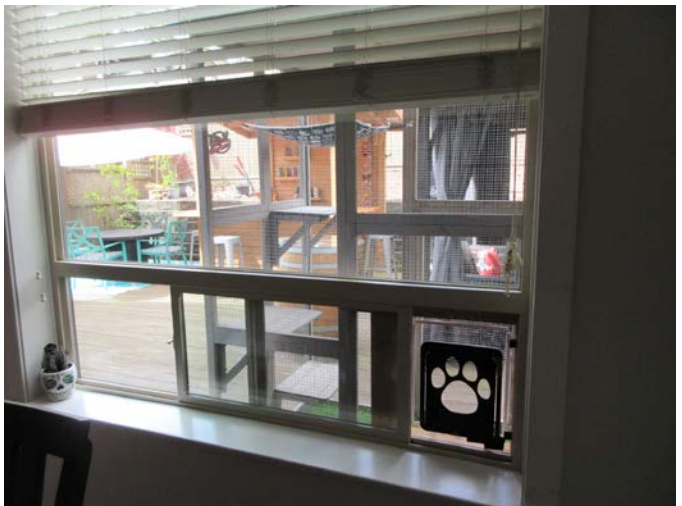
2.3 Window

The house had vinyl window type with double pane. It was functional with no deficiency at the time of this home inspection.

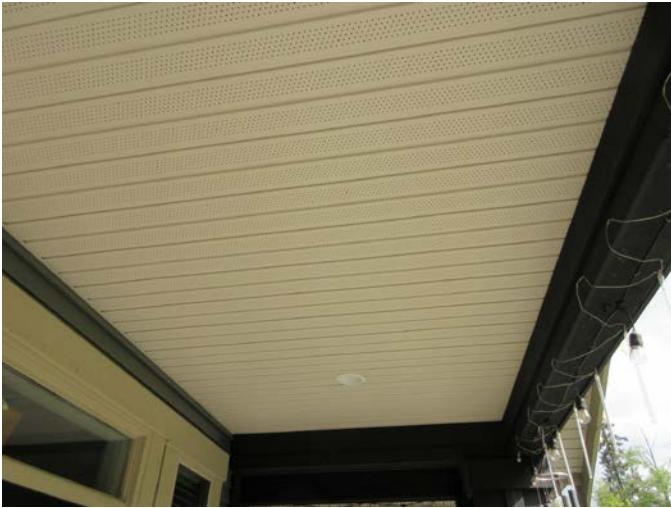
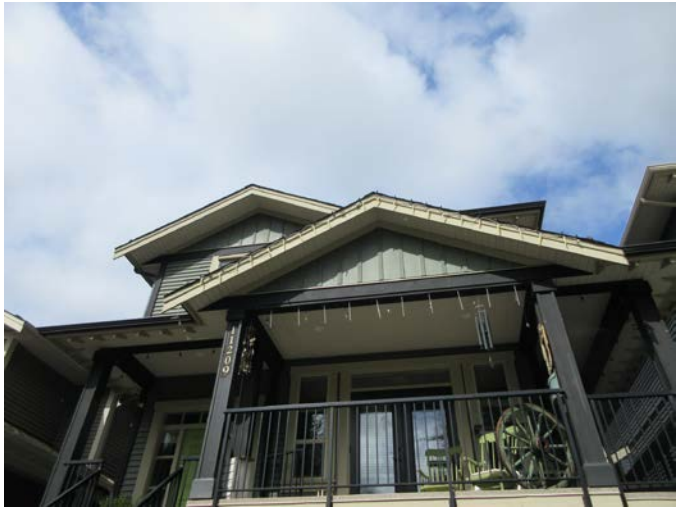
2.4 Soffits and Fascia

The house had wood fascia and aluminum soffits type. The fascia and soffits seems to functioning with no deficiency at the time of this home inspection.

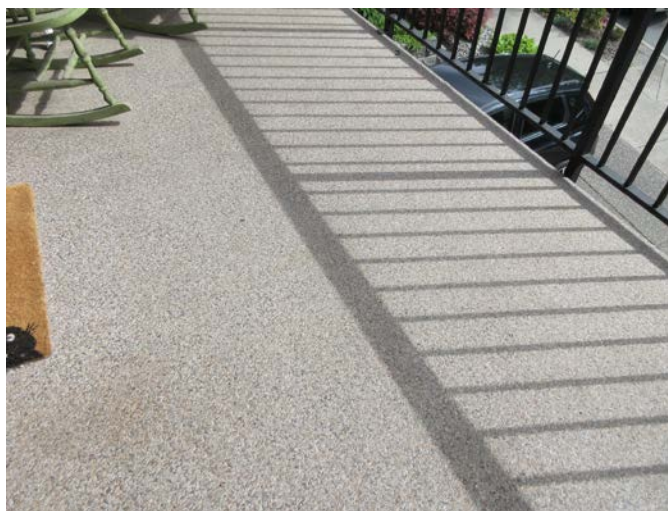
2.5 Balcony

The balcony floor was covered by vinyl rolling on the east side of the house. The balcony showed no deficiency concerns and seems to functioning well at the time of this inspection.

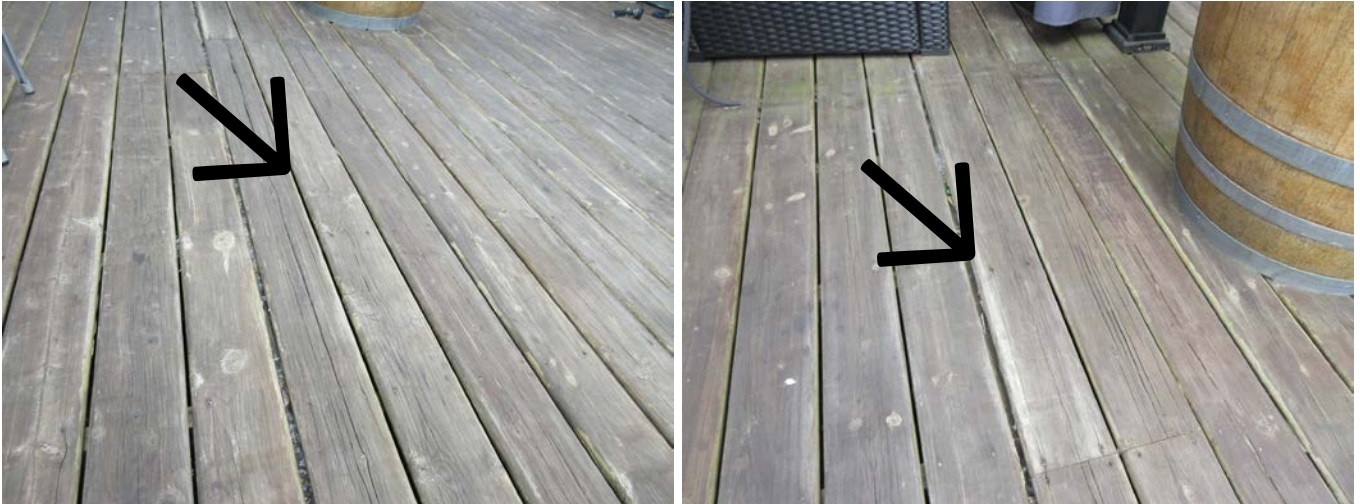
2.6 Deck, Patio, Porches

The deck wood floor had an uneven surface at the backyard of the house. Fixing the floor is recommended.

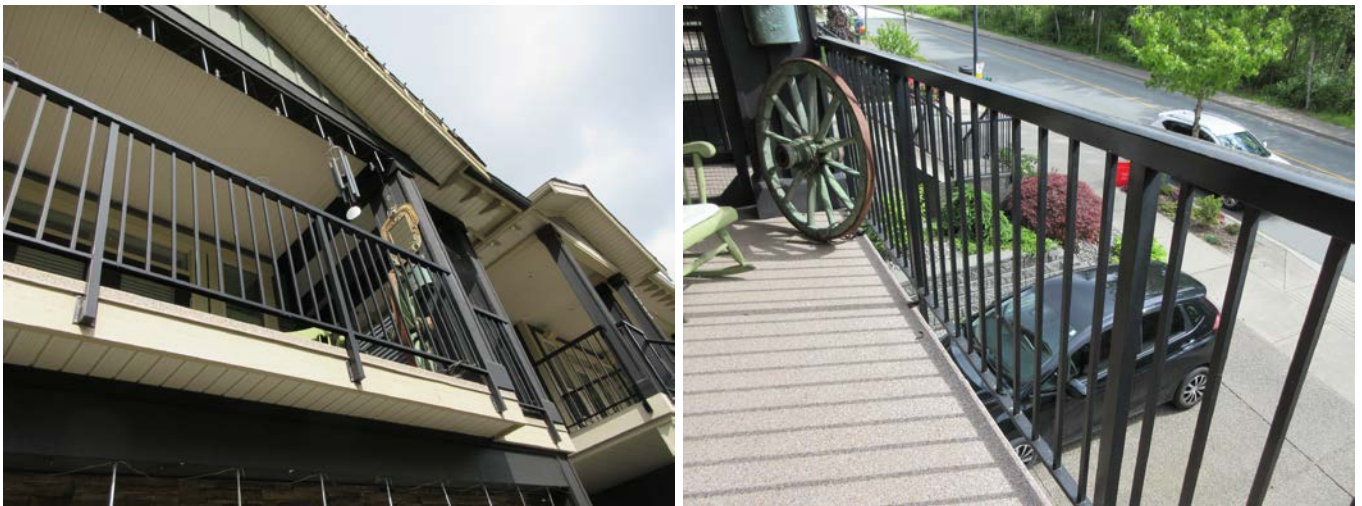
2.7 Guard and Handrail

The house had metal guard for the balcony. The handrail and guard of the balcony were functional with no deficiency at the time of this home inspection.

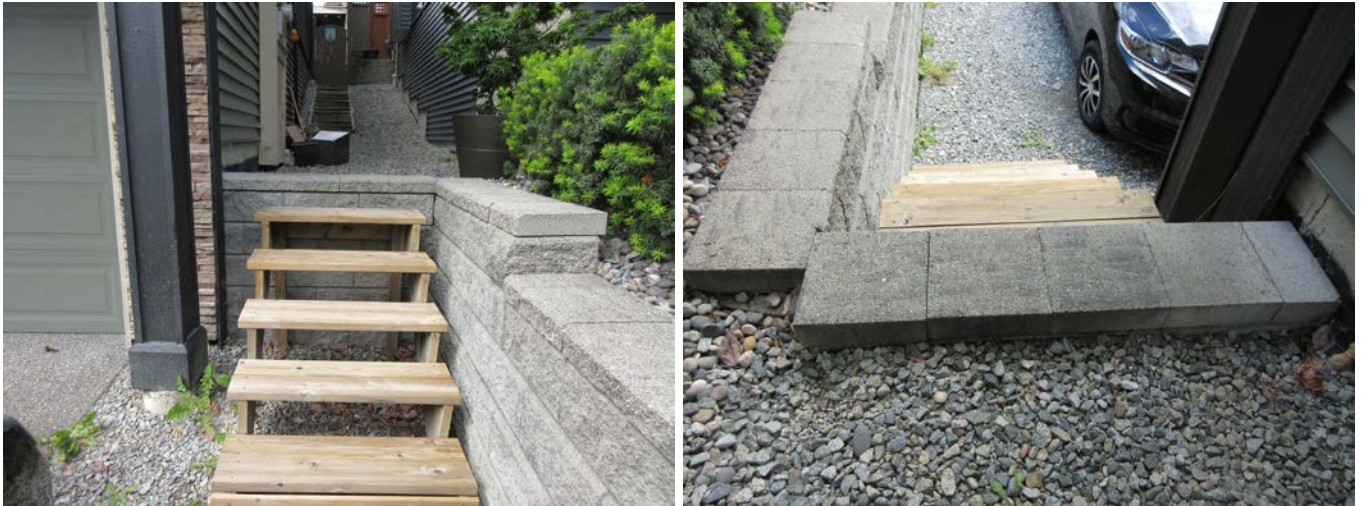
There was no the handrail and guard for stair at the north side of the house. This a safety concern. I recommend instaling the handrail and guard to make it safe.

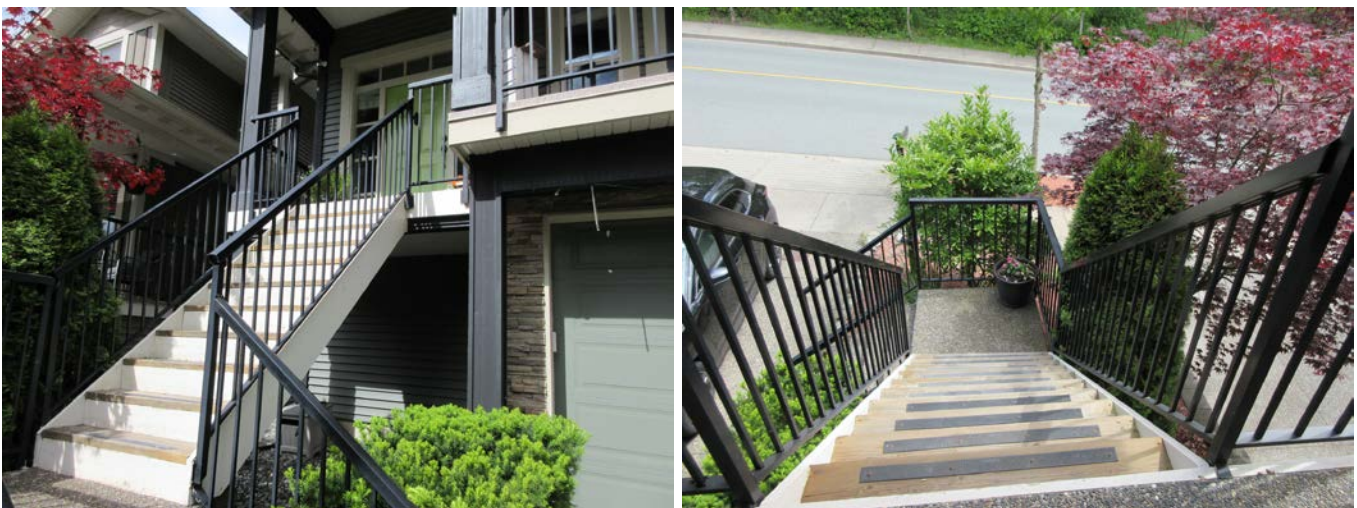
2.8 Stair

The wood stair was noted in front of the house. The exterior wood stair of the house was functional with no deficiency at the time of this home inspection.

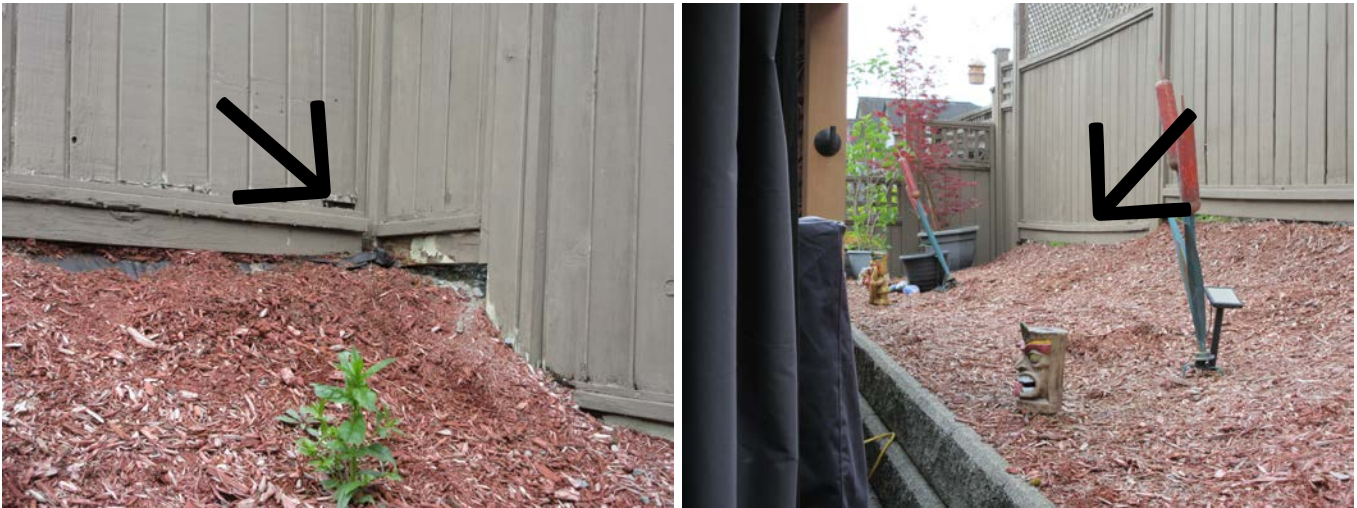
2.9 Fence

A number of the wood boards of fence were rotted and was sagging in the backyard of the house. Fixing the wood fence is recommended.

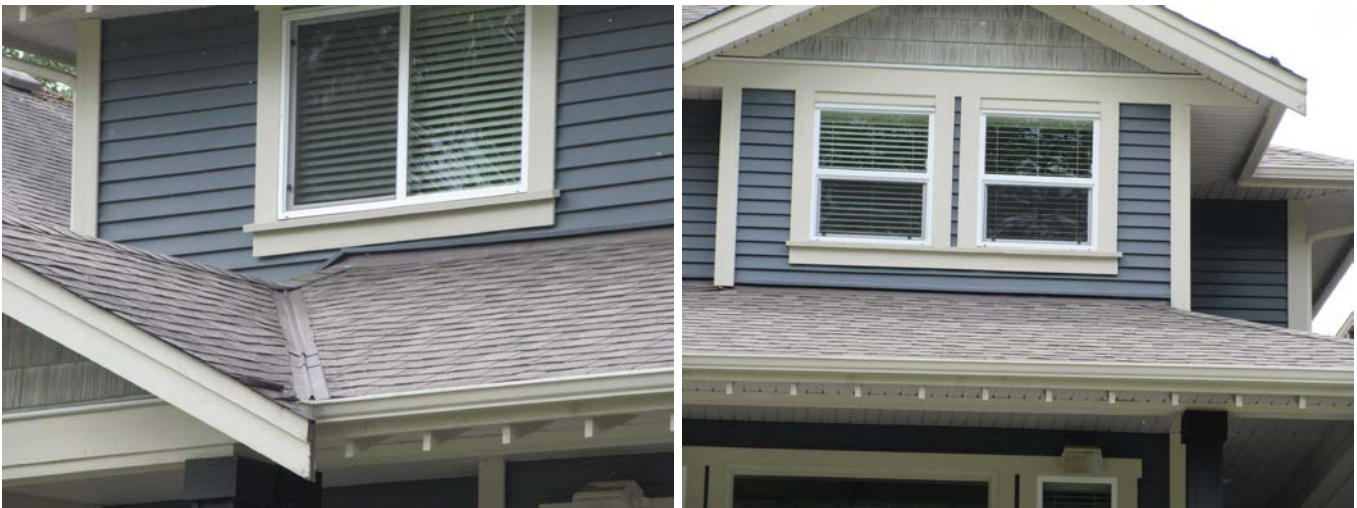
3.1 Roof Covering Material

The house had asphalt shingle roof coverage material. The roof had no damaged or missing shingle. The roof coverage was functioning well at the time of this inspection. The roof coverage with proper care they should serve the house for many years. Typically, asphalt shingle normal service life is 15-20 years. The asphalt shingle seems to be in the second half of its useful life.

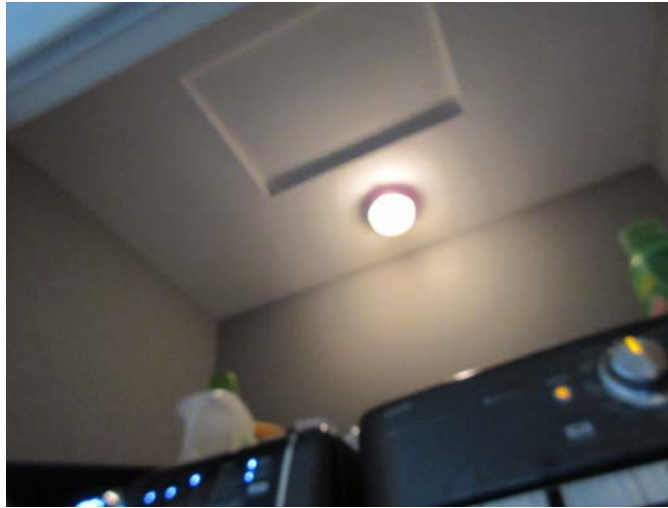
3.2 Attic

The attic hatch door was above the washer at the laundry room of the house. So I could not reach the attic. Access to the attic was limited; for this I was unable to perform a reasonable home inspection.

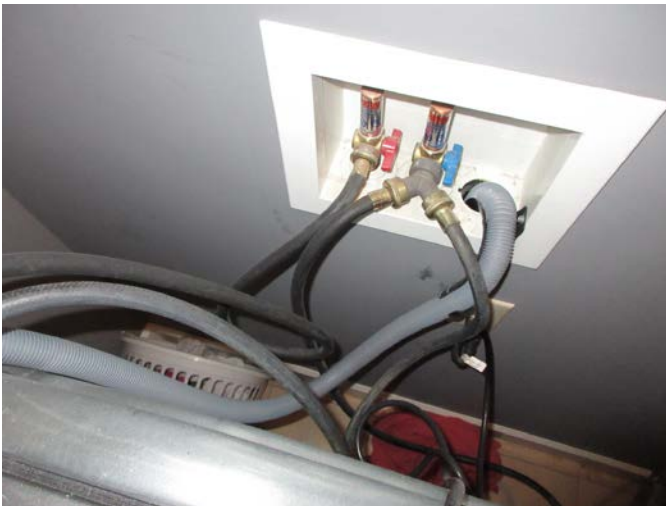
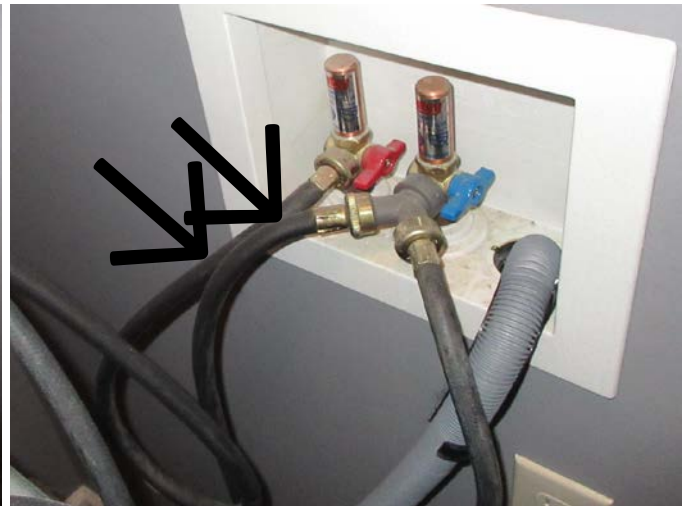
4.1 Washing Machine & Dryer

The rubber hose was used for the supply water of washing machine. The water pressure can expand the rubber hose in the long time. The expanded hose may cause the hose has water leakage. I recommend changing the rubber hose type with the (Braided Metal) flexible tap connector type.

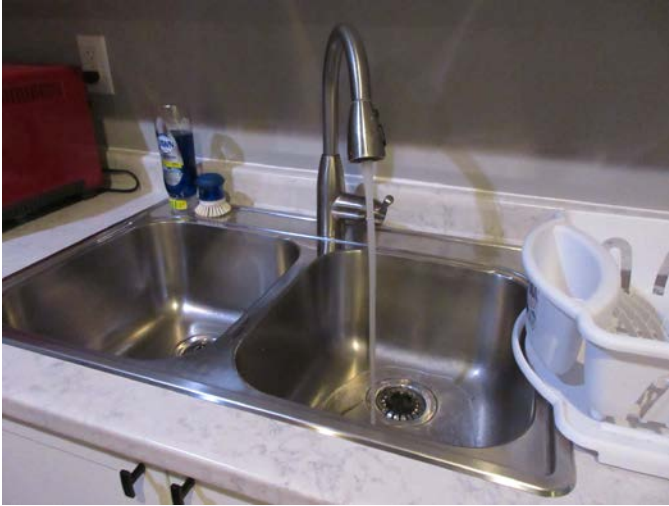
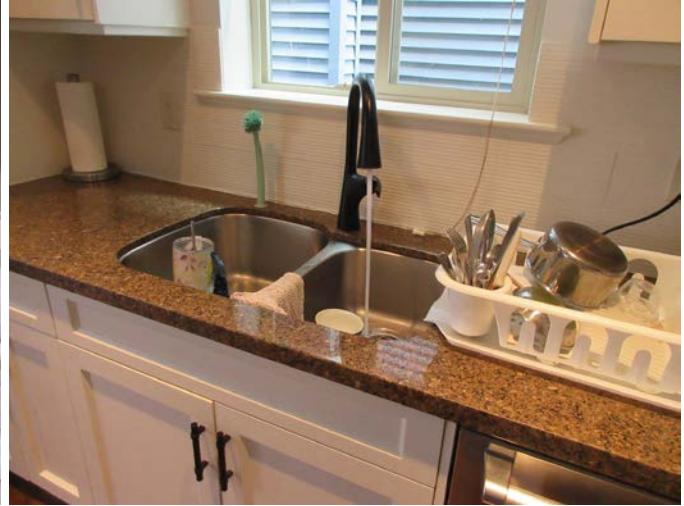
4.2 Kitchen faucet & Sink

The kitchen of the house had steel sink type. The faucets and sink were functioning with no leaks at the time of this home inspection. The water fixture seem to be in satisfactory condition. The water pressure and drainage seem adequate for the kitchen sink.

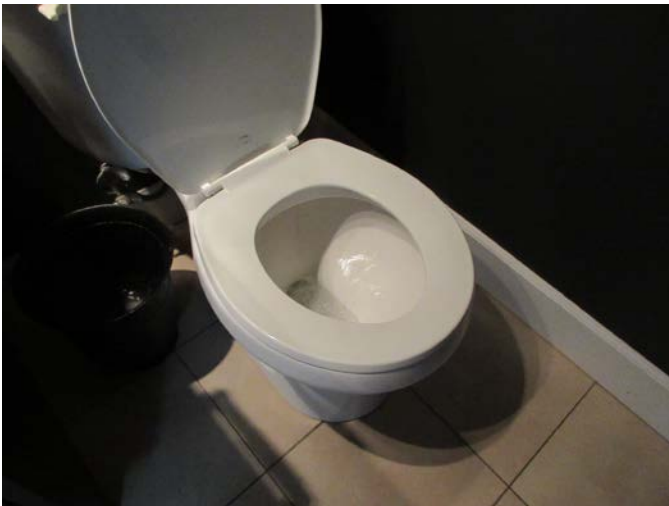
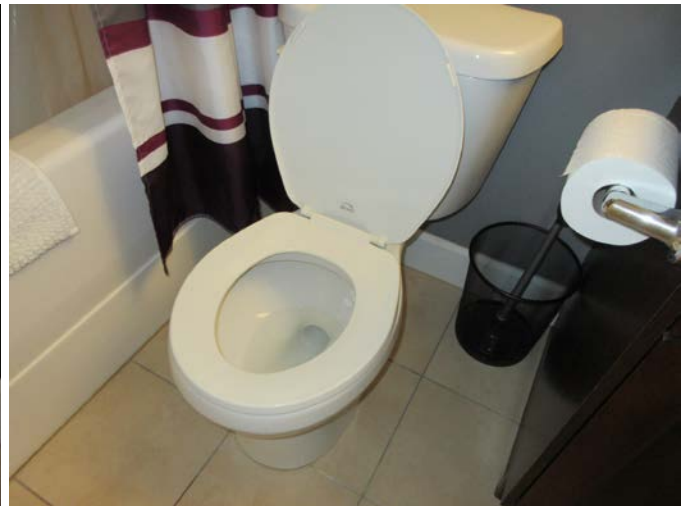
4.3 Toilet and Basin Sewage

All toilets were tested at the house. The toilets and flushing of the house were functional at the time of this home inspection. No cracks or leaks to the flush tanks or toilets. No movement of toilet. The bowl was secure and was functioning with no deficiency at the time of this home inspection.

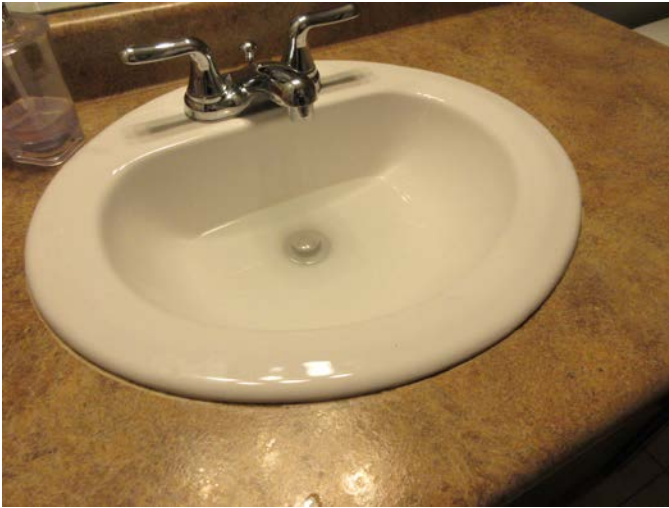
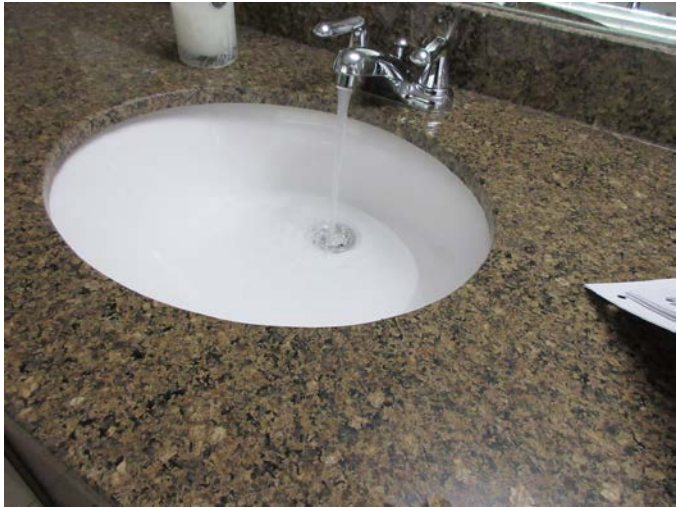
The water clogged was noted on the left basin sewage pipe at the master bathroom of the second floor and basement bathroom as well. The water was discharging slowly. Fixing the water clogged and the sewage pipe is recommended.

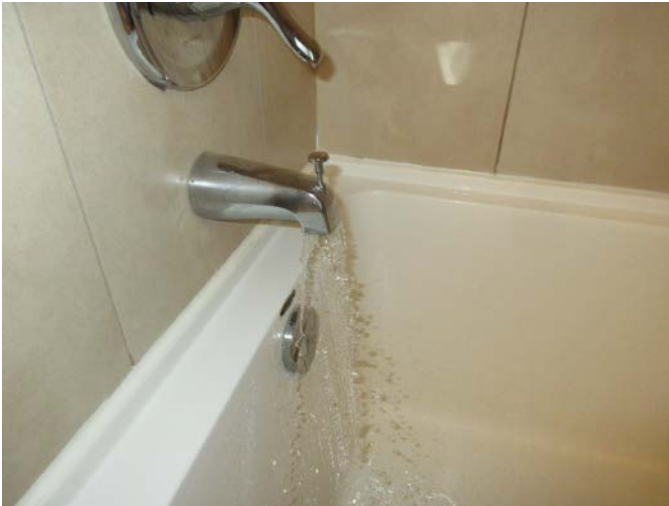
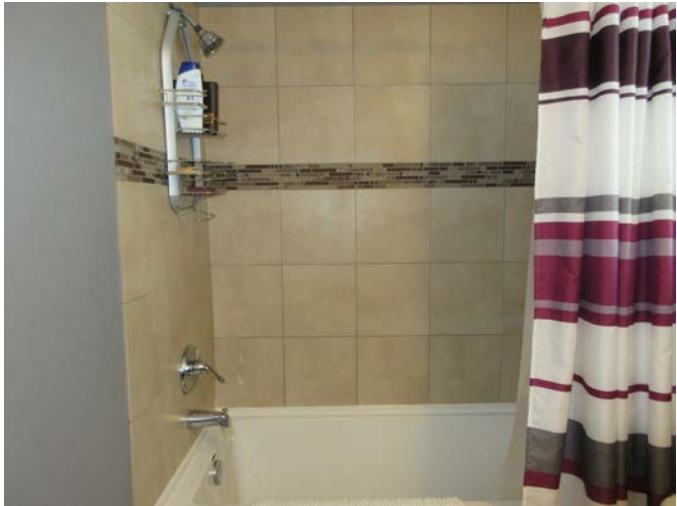
4.4 Bathtub

The main bath room tub faucet was tested at the second floor of the house. The water leakage was observed on the faucet's spout at the second floor main bathroom. Fixing the water leakage is recommended.

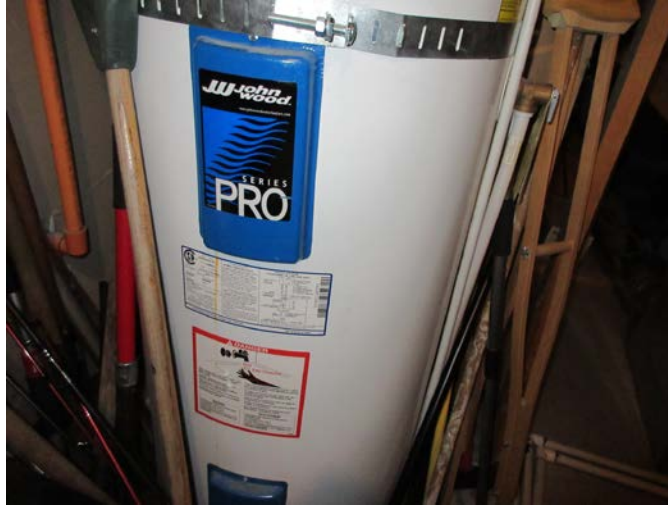
4.5 Hot Water Tank

The hot water tank was manufactured dated Oct 2012. The hot water tank is 12 years old. The water tank life expectancy is 7-12 years. The hot water tank useful life was over and need to be replaced with the brand new. It had no leaks and was functioning well at the time of this home inspection.

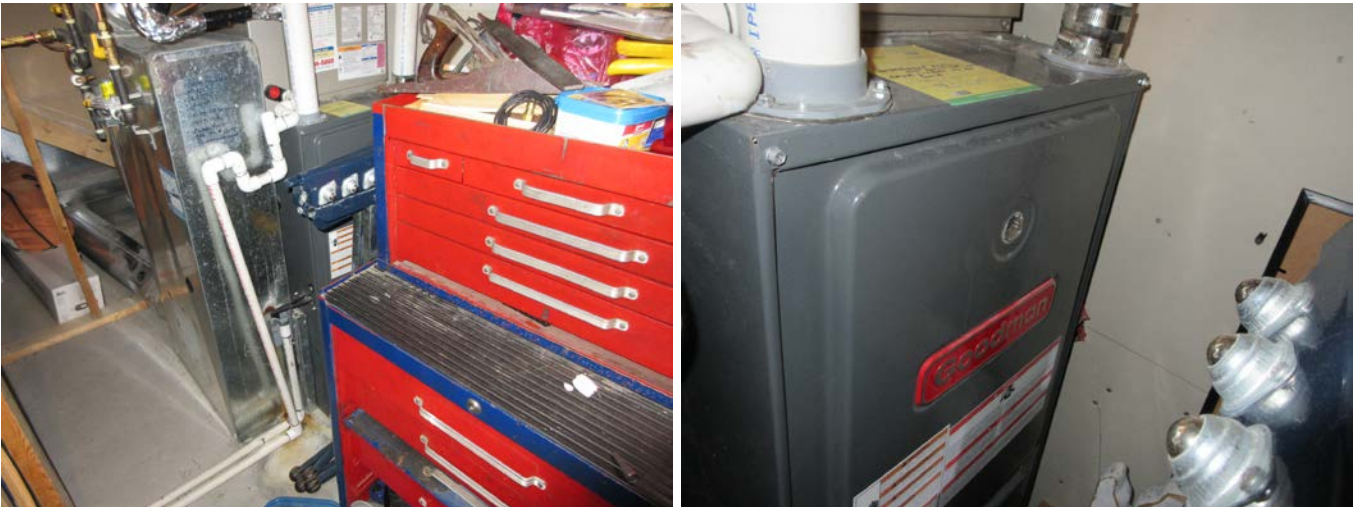
5.1 Furnace & A/C

The house had combination of furnace and A/C. The furnace manufactured in dated 2012. The Furnace is 12 years old. The furnace life expectancy is 15-20 years. The furnace was functional with no deficiency at the time of this inspection.

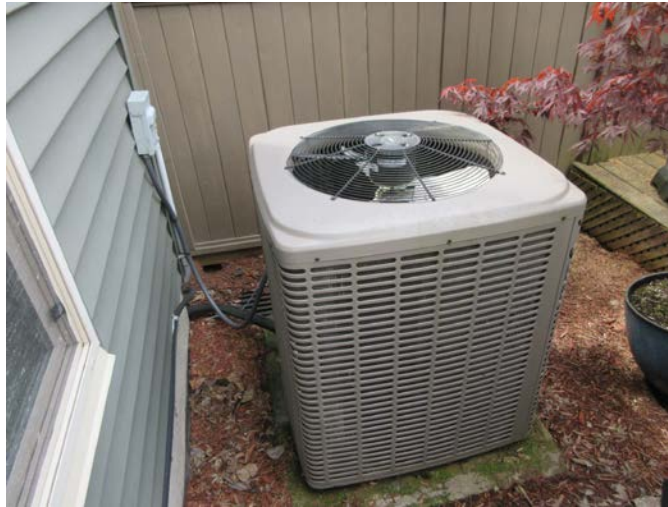
The house had combination of furnace and A/C. The cool mode was not tested due to exterior temperature being below 18°C degrees. Running the unit in this condition can damage the compressor. If concerned about the condition of the unit, request bill of service from homeowner. Both the furnace and AC should be serviced annually.

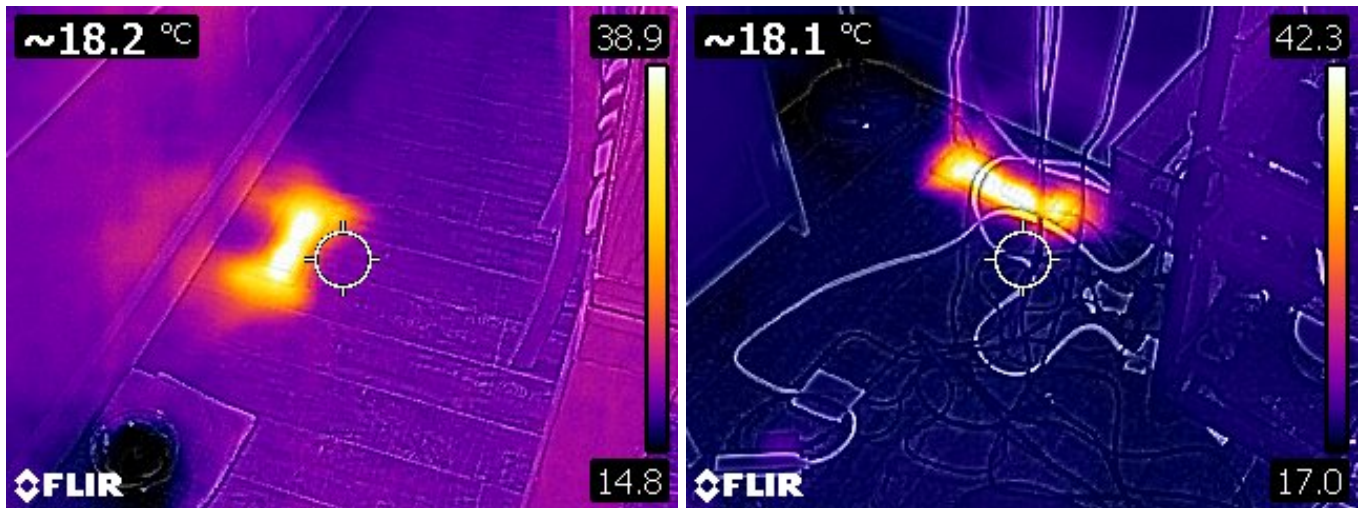
5.2 Heating grill and register

Grills of distributing heating system were tested and functional at the ground and second floor of the house. As the ceiling heating ducts were small at the basement of the house, the heating didn't disturbed enough to the basement unit space. Fixing the heating duct by qualified contractor is recommended.

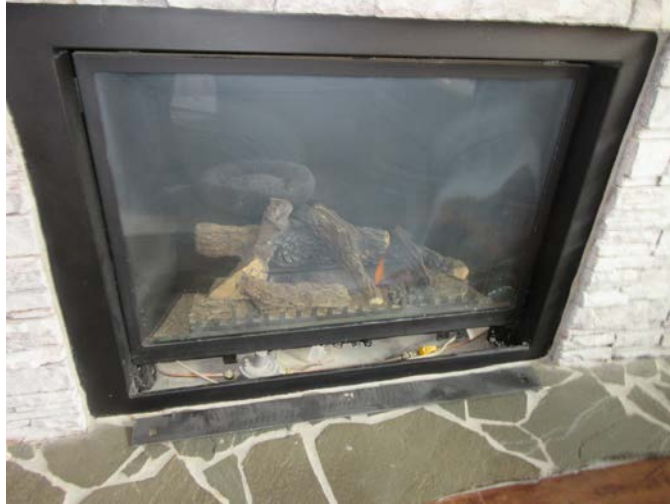
5.3 Fireplace

The house had gas fireplace type. There was no protective safety screen / glass in front of the fireplace. The fireplace had the smoke glass and the dust under the setting switches. Cleaning the fireplace glass is recommended.

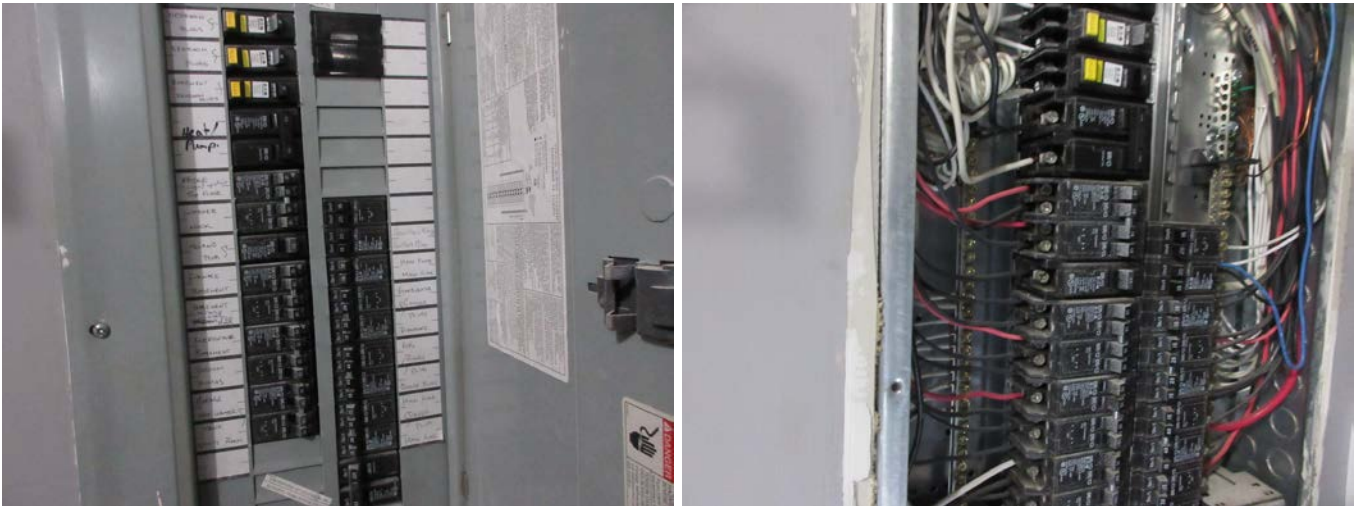
6.1 Main Electrical Panel

The electrical panel was 125 Amp and the main breaker was 125 Amp. The main panel was located in the north side of garage and professionally was installed. The wire type of the house was copper. It shows no burnt, damaged, or corroded wires. Breakers were labelled. Appropriate circuit breakers and sized wires were used for specific circuits (i.e. 40 amp for the range, 30 amp for the dryer, and 15 amp for general circuitry).

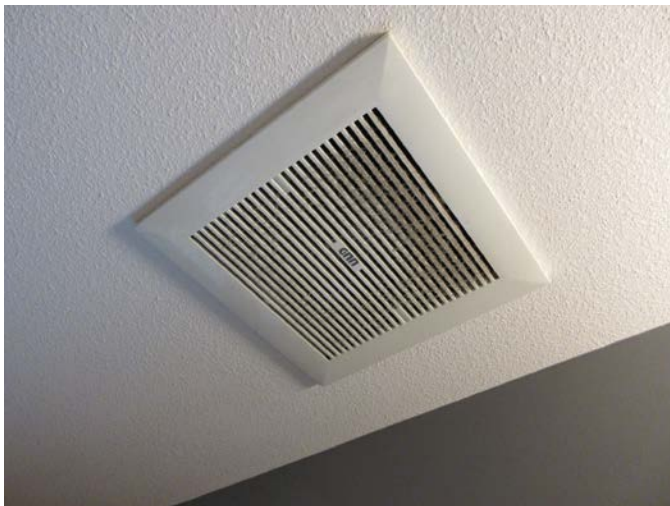
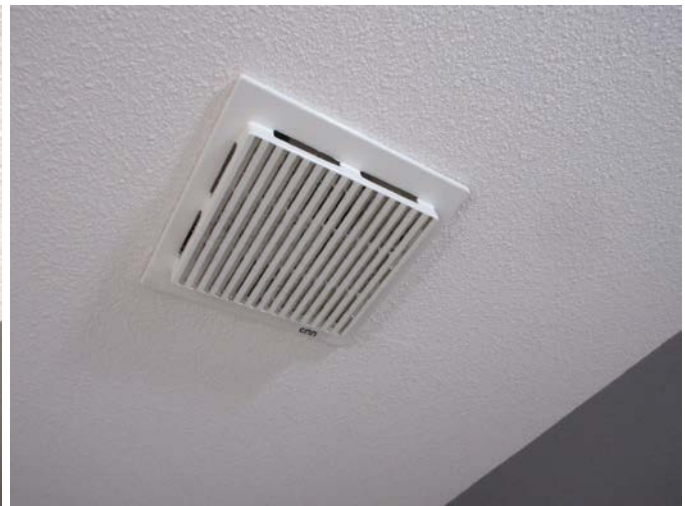
7.1 Bathroom & Washroom

There were electrical exhaust fans in the bathroom at the basement and second floor of the house. The exhaust fan in the master bathroom and main bathroom were functional with no deficiency at the time of this home inspection. The main bathroom electrical exhaust fans grill was dirty and clogged with dust at the second floor of the house. I recommend cleaning the grill of the fan for better functionality.

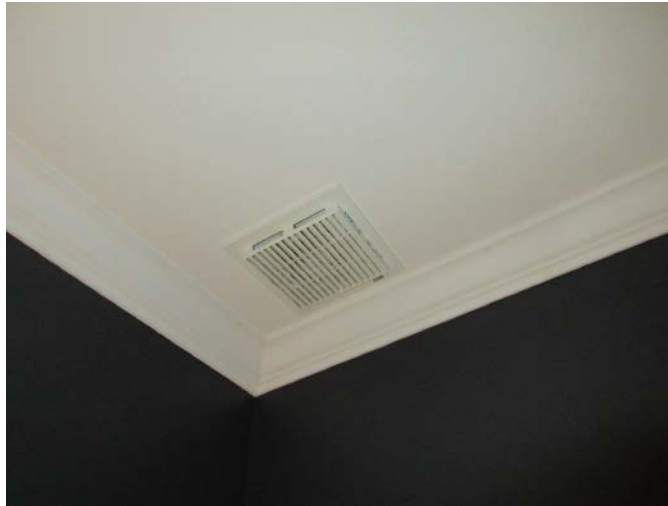
I was not able to turn on the exhaust fan of the washroom at the ground floor of the house. Fixing the exhaust fan is recommended.

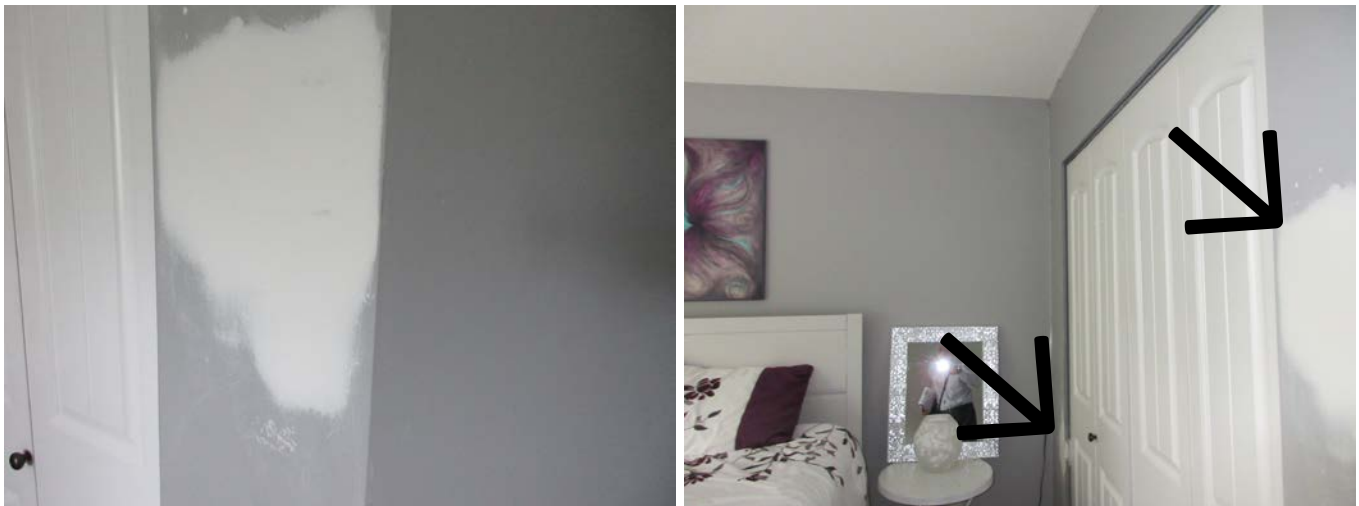
8.1 Wall and Material

Two points of bedroom dry wall was fixed with no painting at the second floor of the house. It is likely to be cosmetic issue. The fixed points on the wall need to re-painting as recommended.

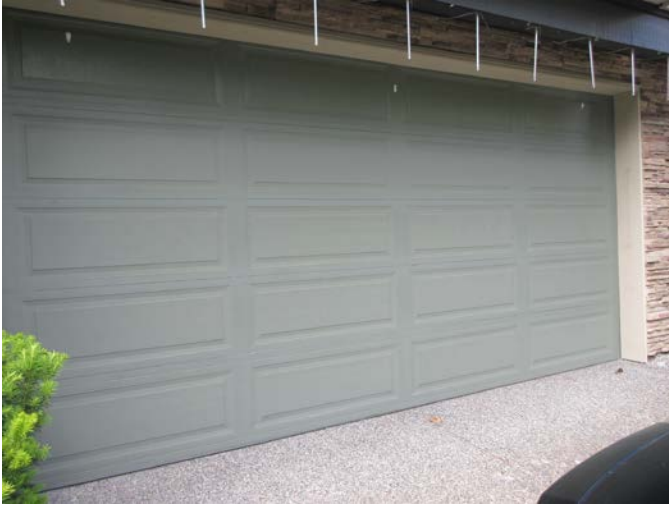
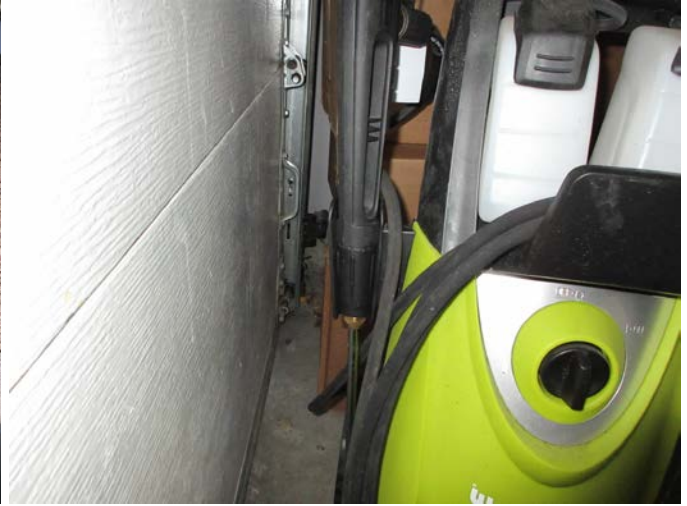
8.2 Garage

The garage door was functioning and mechanically smooth. The sensors were in place for the garage door and reversed the door at the time of this home inspection.

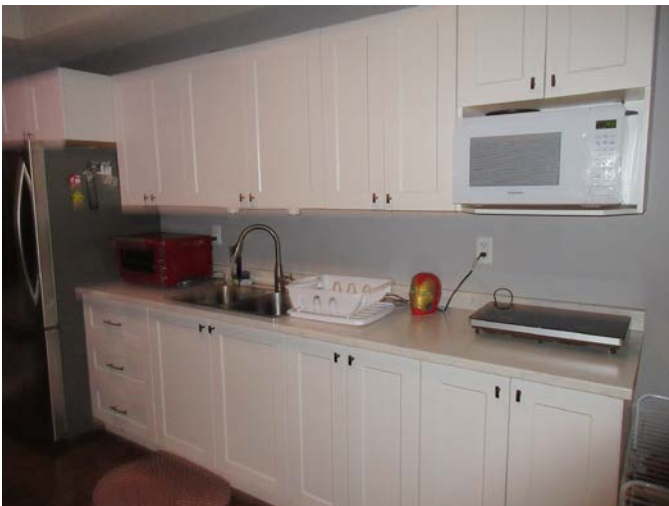
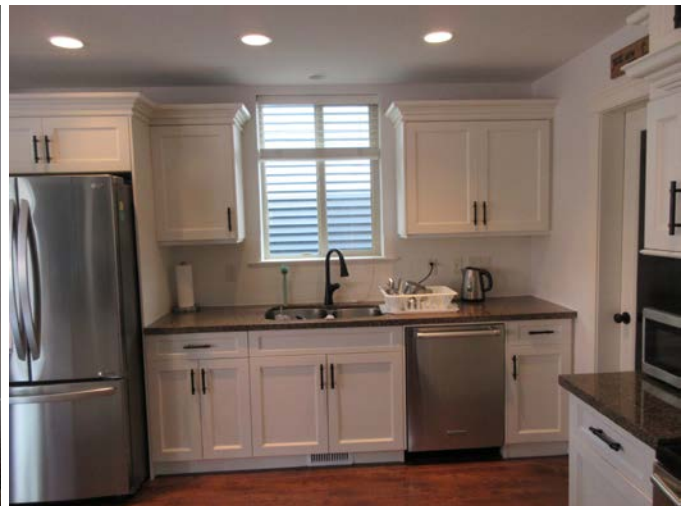
8.3 Counter and Cabinet

The house had stone and quartz countertop type with vinyl type for cabinet door. The cabinet and counter of the kitchen were functional with no deficiency in the house at this home inspection.

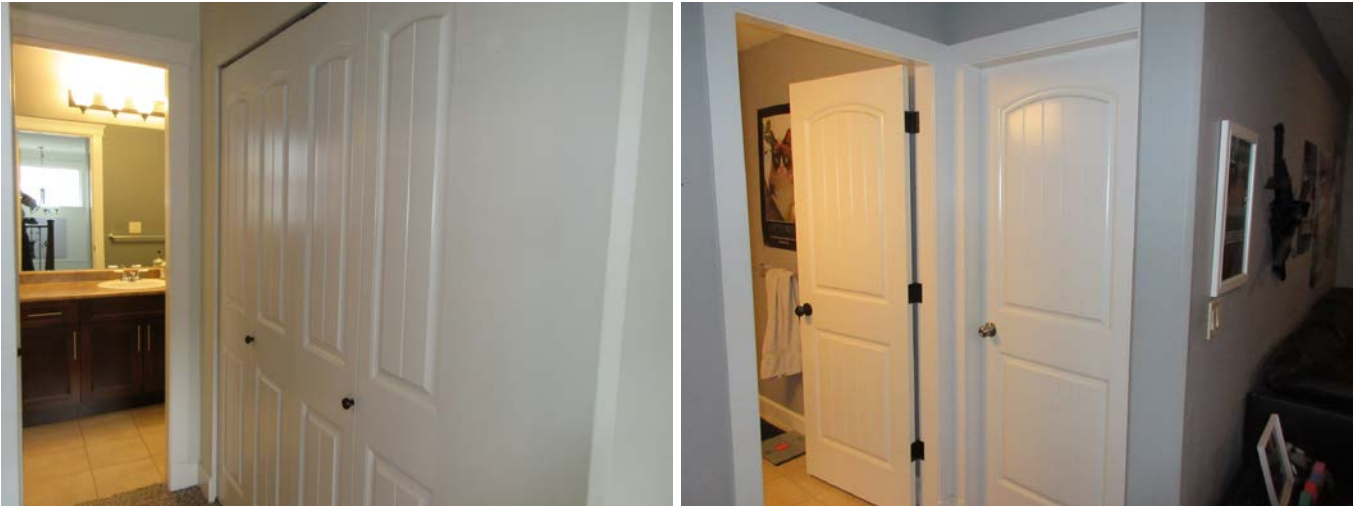
8.4 Door & Closet door

The house had vinyl door type for rooms and bifold closet door. The interior doors, closet doors, and hardware were functioning and likely perfect with no deficiency at the time of this home inspection.

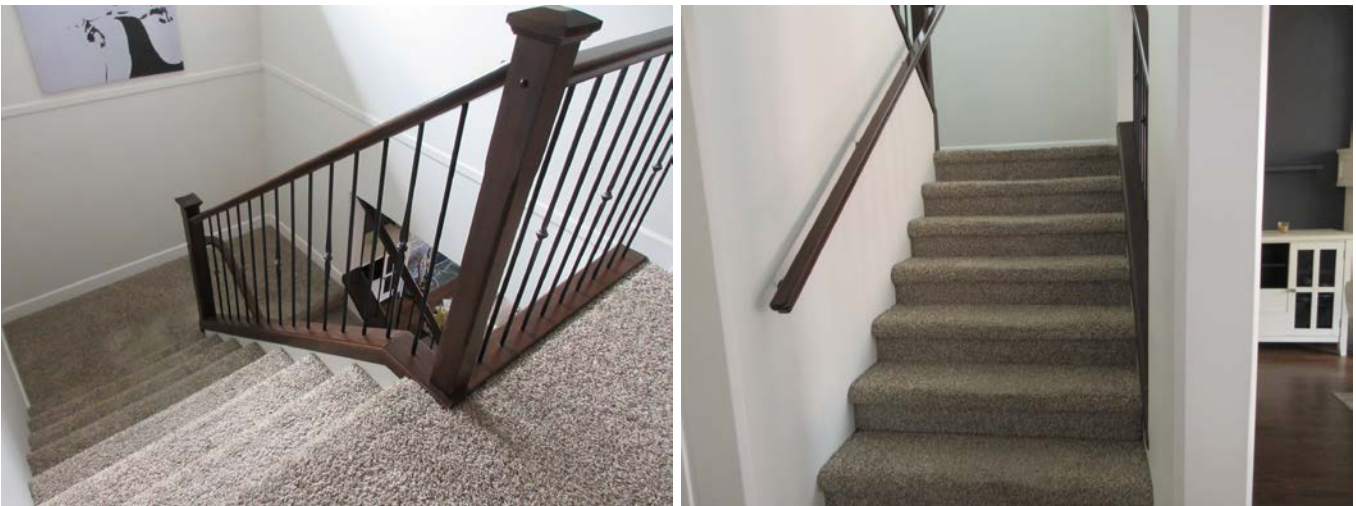
8.5 Stair, Railing and Guard

The interior stair was covered by carpet. The stair was functional and the handrail was installed properly with no deficiency at the time of this home inspection.

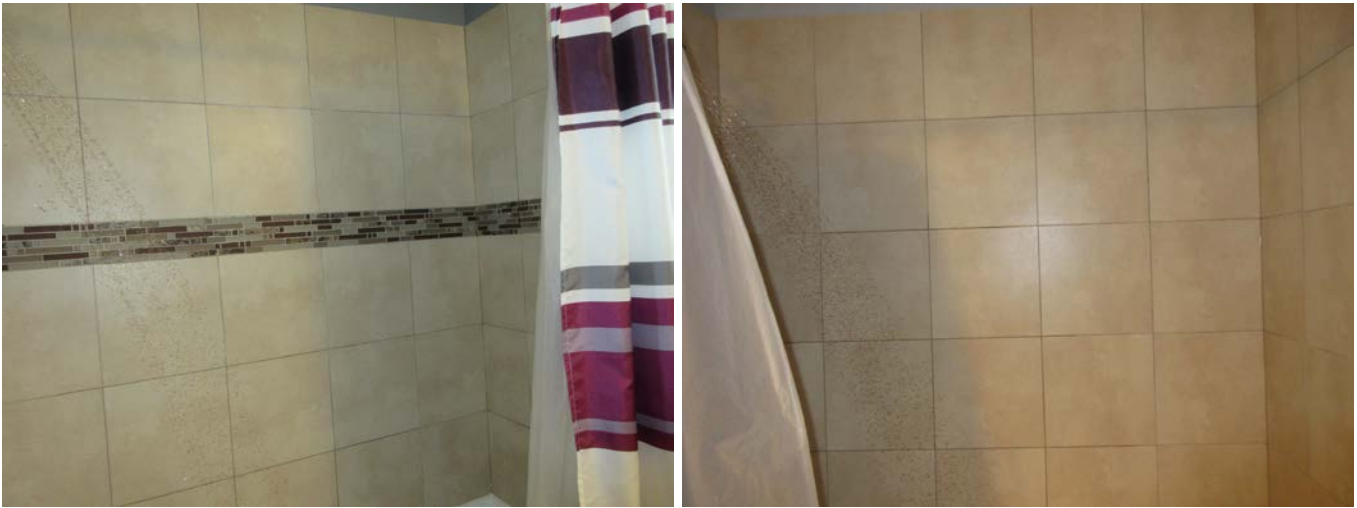
8.6 Bathtub

The master bathroom and main bathroom shower wall tiles and grout looks perfect with no deficiency at the time of this home inspection. The grout serving the shower tiles showed no deficiency at the time of this home inspection. Periodic sealing the connection point of the tile and the tub is necessary to prevent water penetration.
