ABC Home Inspections

Home Inspection Report

Prepared exclusively for
Maple Ridge, BC

Property Address: Maple Ridge, BC
 Date of home inspection: Thursday, May 23, 2024
 Inspection start time: 10:00 AM
 Inspection end time: 1:30 PM
 MLS#: not available
 Year Built: 2011
 Construction: -
 Furnished: Yes
 Occupied: Yes
 Floor Area Total: 2862 sq. Ft.

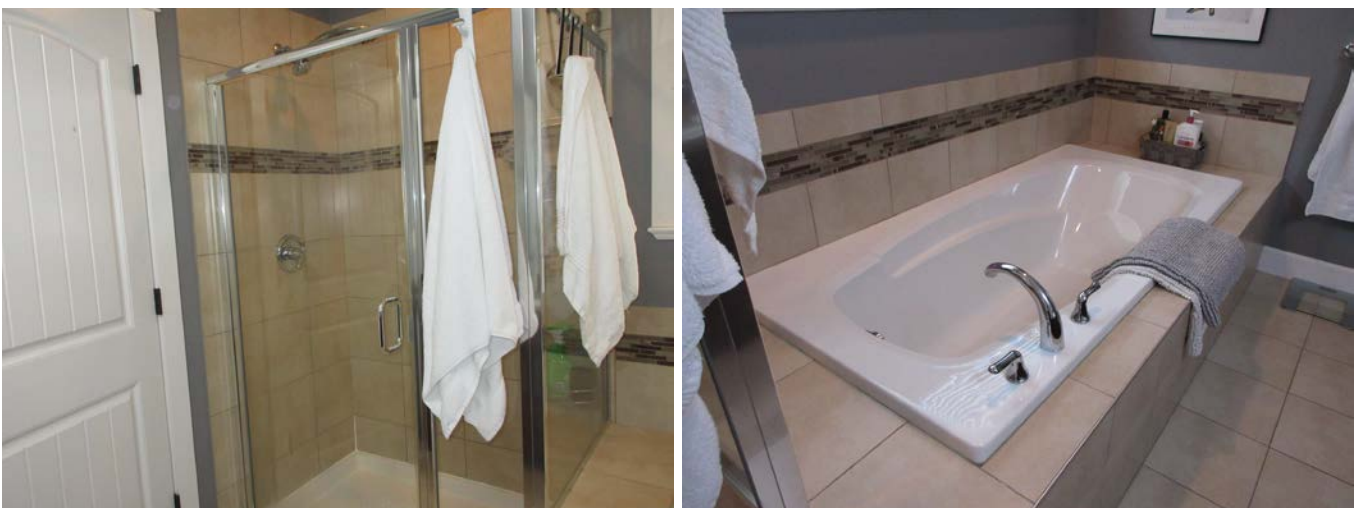
8.7 Shower stall

The stall and shower were functional at the time of this home inspection. It seemed well with no deficiency at the time of this home inspection.

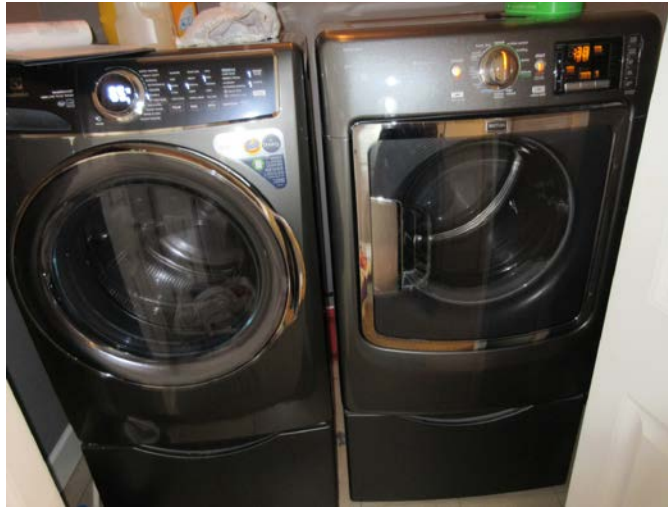
8.8 Washing machine and dryer

The washing machine and dryer were tested in the laundry room. There was no water leakage for washing machine. The washer and dryer were both functioning at the time of this home inspection.

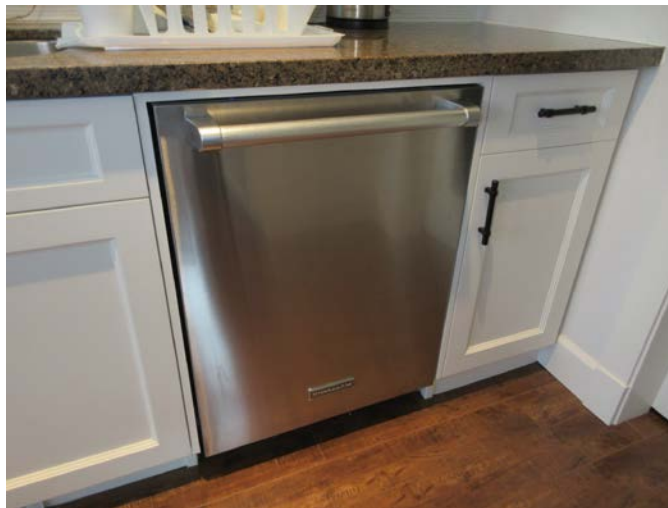
8.9 Dishwasher

The dishwasher was tested. It was likely perfect with no water leakage at the time of this home inspection.

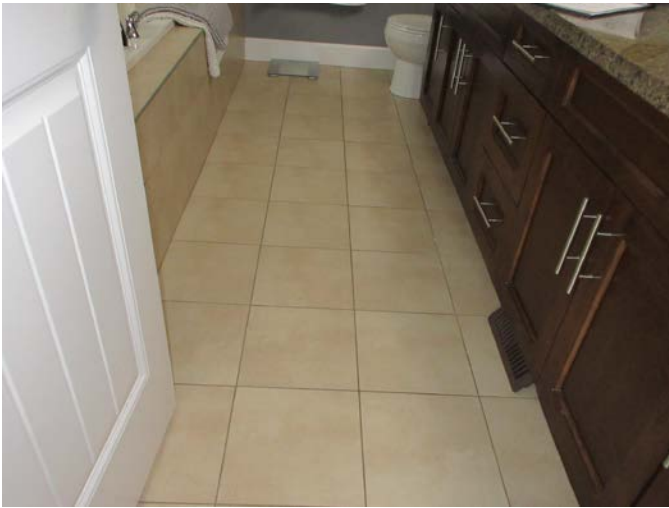
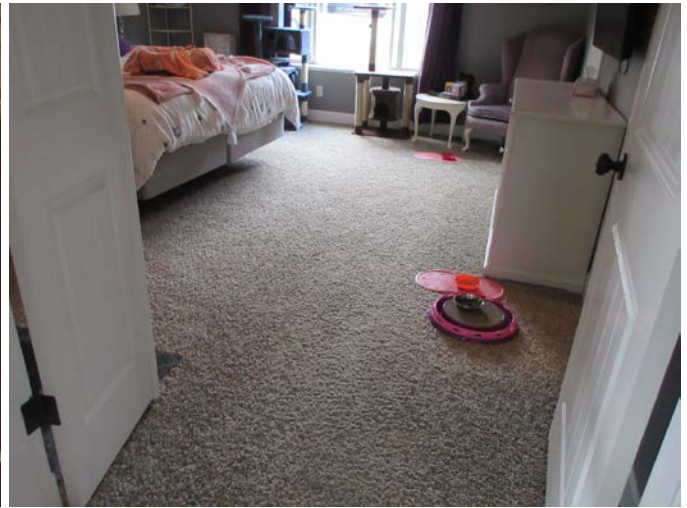
8.10 Floor cover

The house floor was covered by tile, carpet, and laminate at ground and second floor of the house. It was likely perfect with no deficiency at the time of this home inspection.

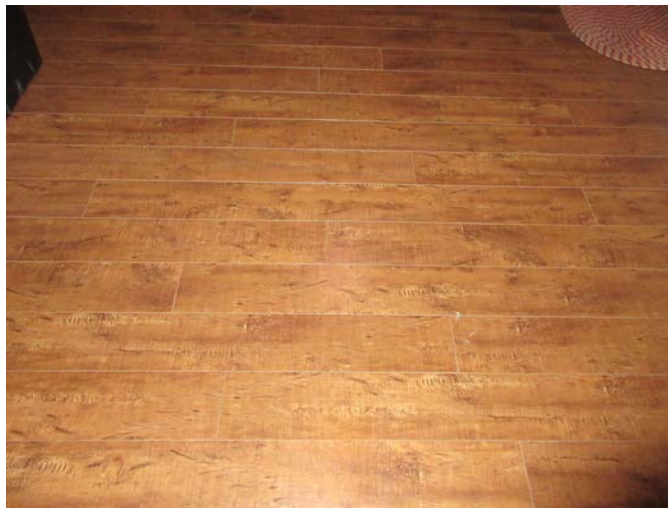
The floor coverage was laminate in the front of kitchen at the basement of the house. Minor bubbling laminate flooring was noted. Fixing the floor laminate is recommended.
