ABC Home Inspections
Home Inspection Report
Confidential

Prepared exclusively for
Coquitlam, BC

Property Address: Coquitlam, BC
 Date of home inspection: Saturday, June 22, 2024
 Inspection start time: 10:00 AM
 Inspection end time: 12:15 AM
 MLS#: not available
 Year Built: 1994
 Construction: Concrete / Wood
 Furnished: Yes
 Occupied: Yes
 Floor Area Total: 1201 sq. Ft.

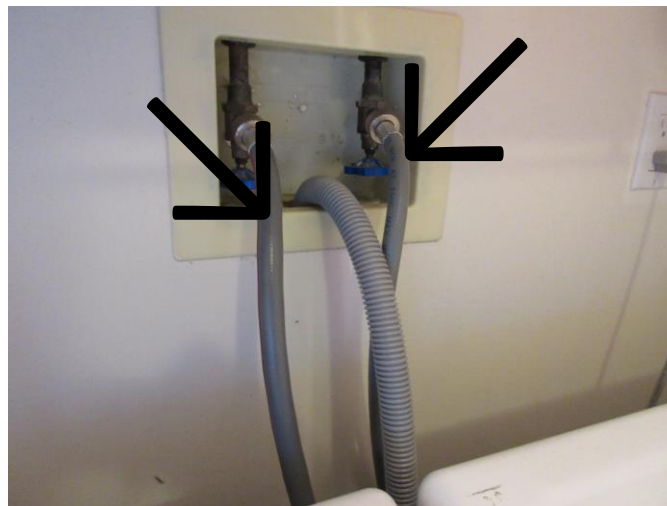
3.2 Washing Machine & Dryer

The rubber hose was used for the supply water of washing machine. The water pressure can expand the rubber hose in the long time. The expanded hose may cause the hose has water leakage. I recommend changing the rubber hose type with the (Braided Metal) flexible tap connector type.

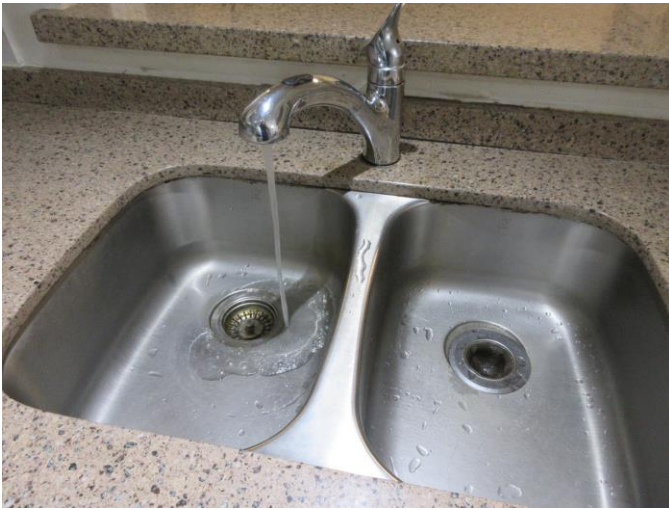
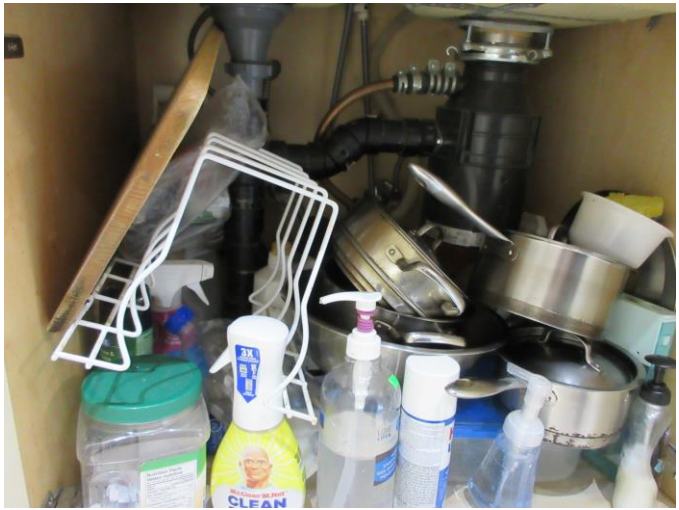
3.3 Kitchen sink & Faucet

The kitchen of the house had steel sink type. The faucets and sink were functioning with no leaks at the time of this home inspection.

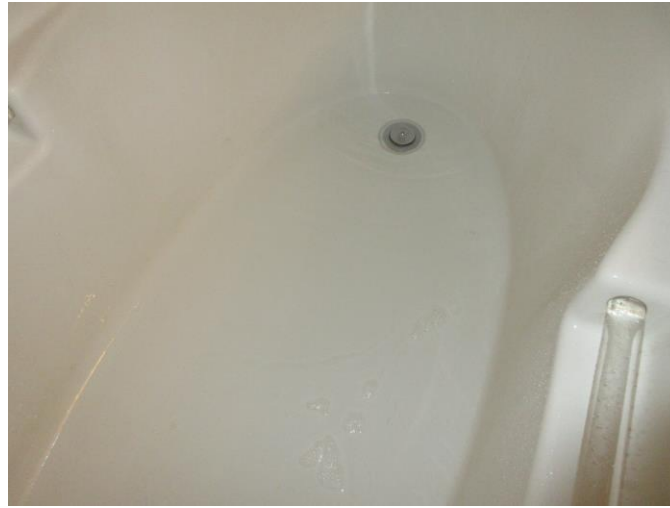
3.5 Bathtub

The minor water clog was noted in the tub. The water was discharging slowly from bathtub at the master bathroom. Fixing water clogging is recommended.

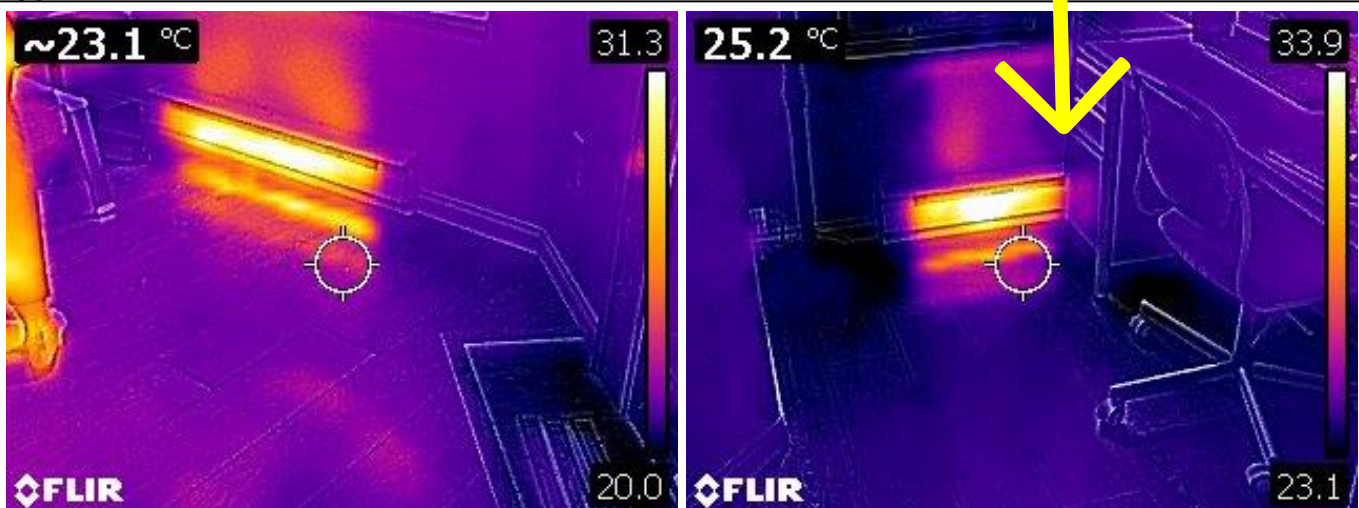
4.2 Electrical baseboard heater

All electrical baseboard heaters were tested and were functioning well at the time of this home inspection. I recommend keeping furniture and textiles, like drapes, sofa away from the unit to avoid fire hazards and ensure your system runs efficiently.

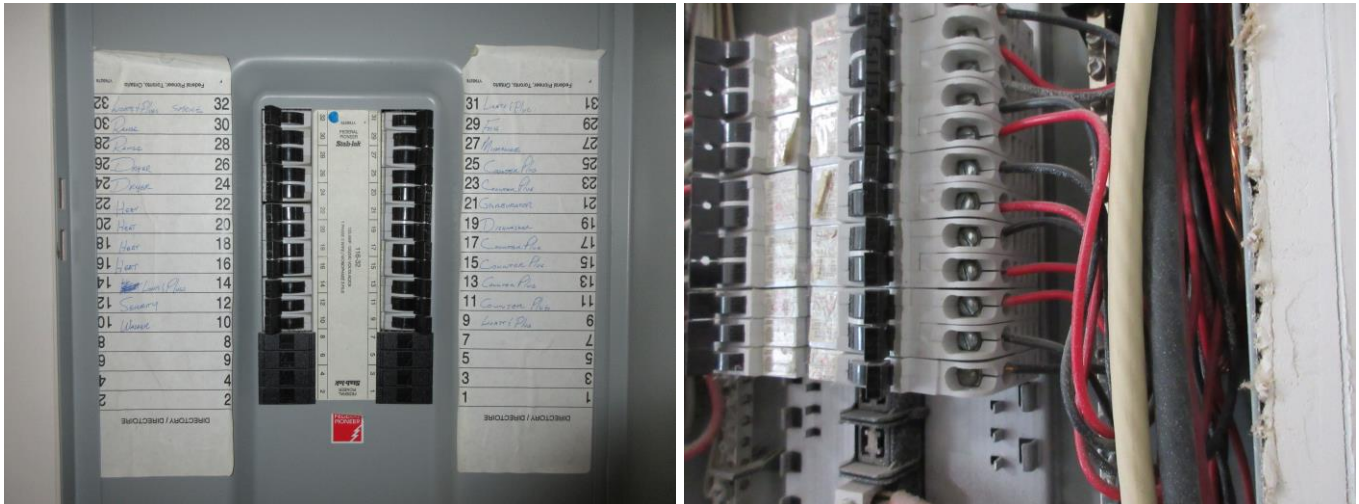
5.1 Main Electrical Panel

The main panel was located in the northeast corner bedroom and professionally was installed. The wire type of the house was copper. It shows no burnt, damaged, or corroded wires. Breakers were labelled. Appropriate circuit breakers and sized wires were used for specific circuits (i.e. 40 amp for the range, 30 amp for the dryer, and 15 amp for general circuitry).

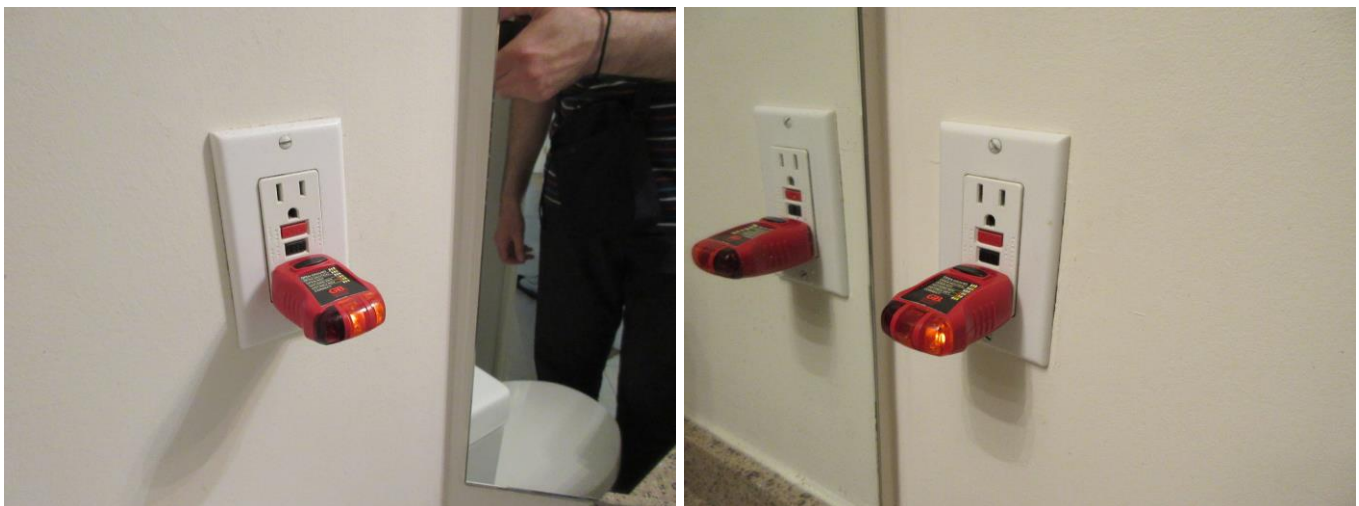
5.2 Outlet and Switch

There were GFCI type outlet in bathrooms and in the washroom of the house. GFCI outlets were tested and appeared to be in serviceable condition on the day of this home inspection.

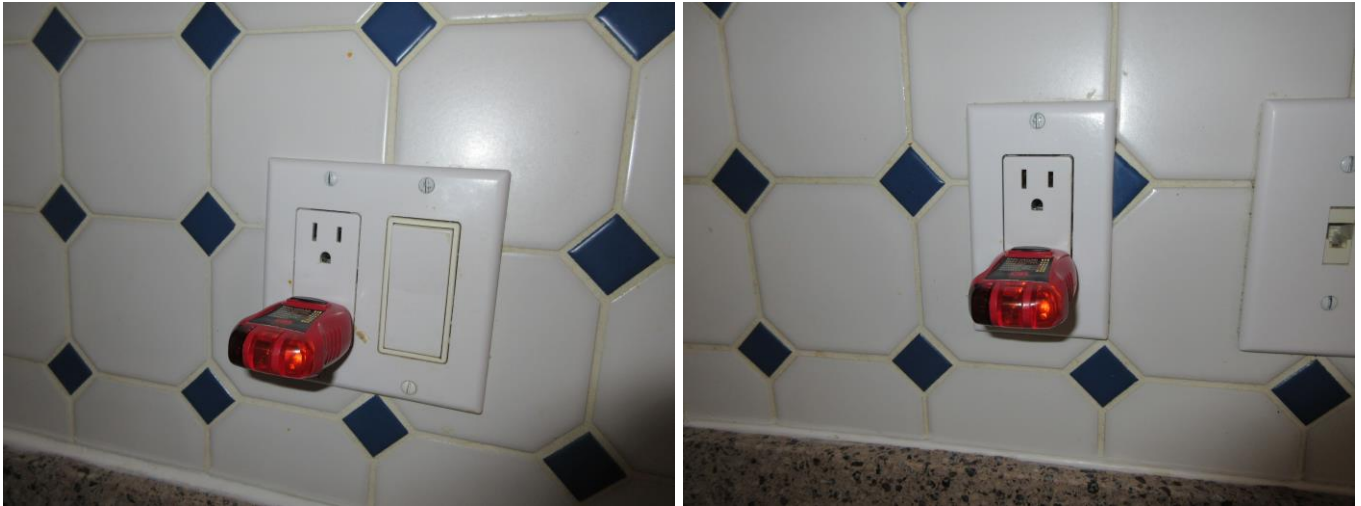
There were no GFCI type outlet in kitchen of the house. The regular outlet was installed in the kitchen of the house. It is safety concern. The outlet needs to be GFCI type in the kitchen to protect users from any electrical shock and unsafe situation. Ground Fault Circuit Interrupter (GFCI) outlets are recommended for installation at kitchen outlets.

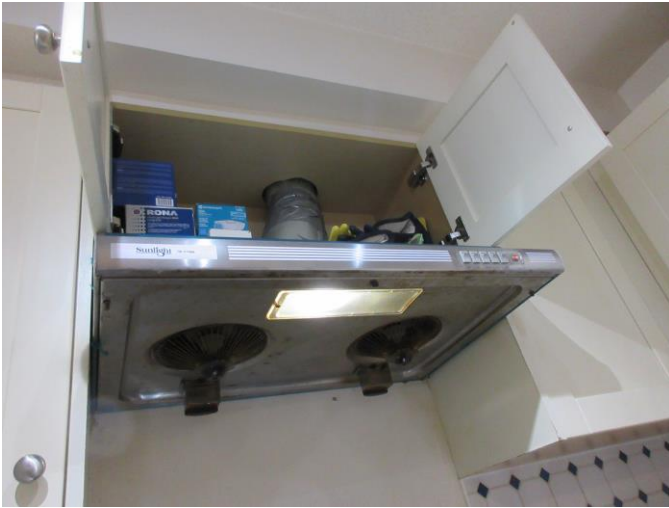
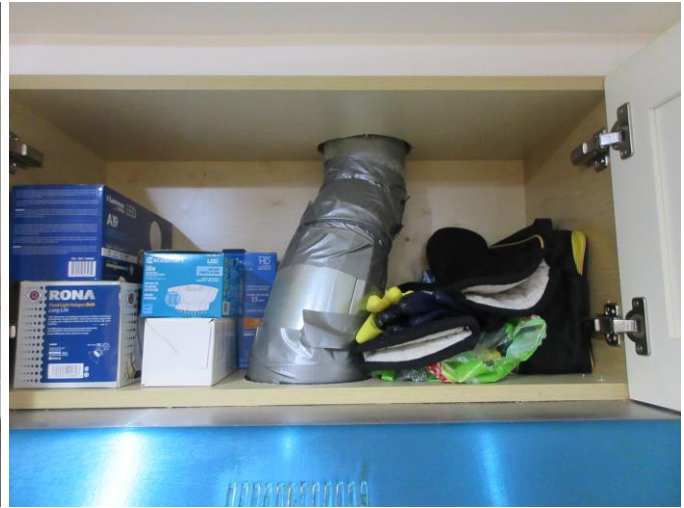
6.3 Rang Hood

The house had electrical range hood. The range hood electrical exhaust fan was tested and was functional at the time of this home inspection.

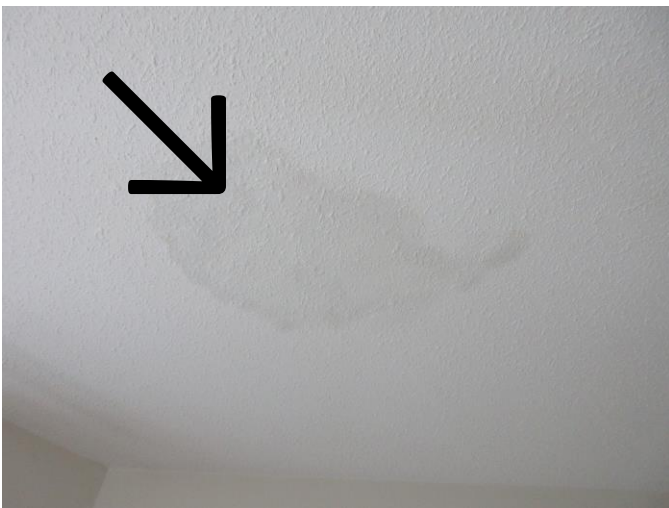
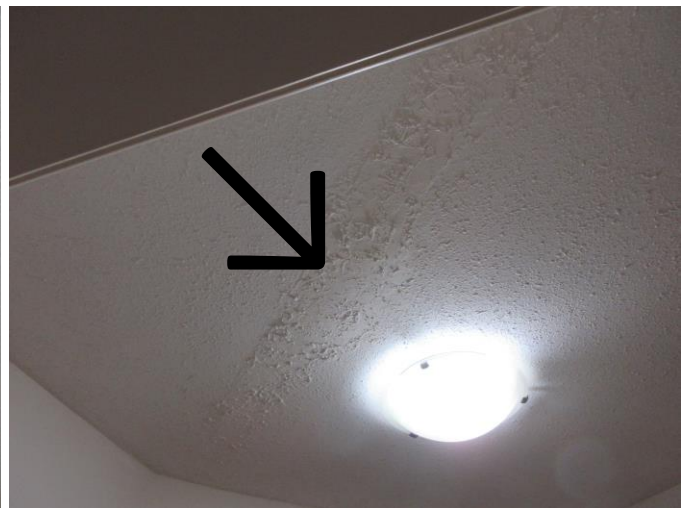
7.1 Ceiling

The old water leakage stain and damaged point was observed on the ceiling of the bedroom and corridor. The moisture stain and damage point was dry at the time of this home inspection. The moisture stain need to be monitored for any changes contacting a qualified contractor for more action as recommended.

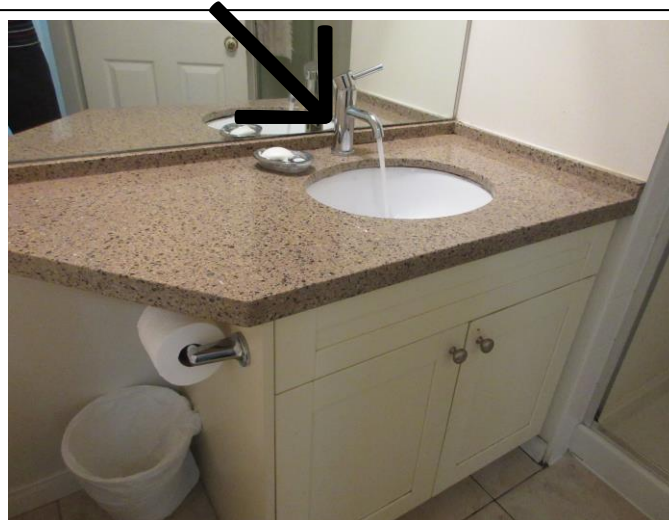
7.5 Bathroom

The basin stopper was not functional in main bathrooms of the house. Fixing the stopper is recommended.

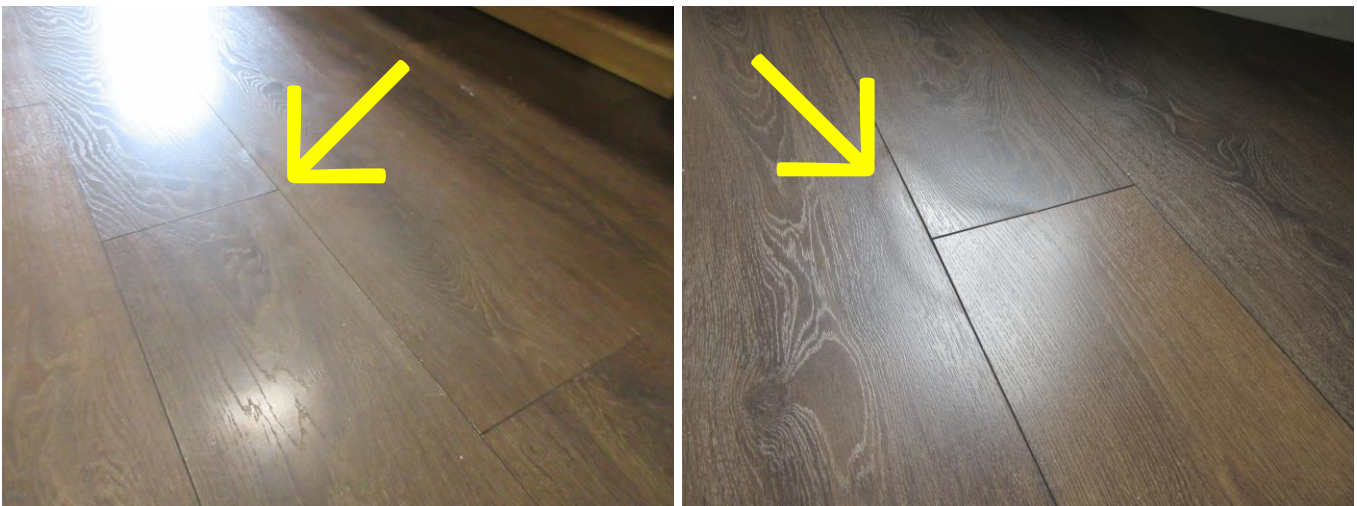
7.9 Floor cover

The house floor coverage was laminate. Minor buckling and lifting laminate flooring was noted at the second floor of the house. Fixing the floor laminate is recommended.
