ABC Home Inspections  
**Home Inspection Report**  
**Confidential**

Prepared exclusively for  
87 Nelson St, Vancouver, BC

Property Address: 87 Nelson St, Vancouver, BC  
Date of home inspection: Thursday, July 25, 2024  
Inspection start time: 10:00 AM  
Inspection end time: 12:15 AM  
MLS#: not available  
Year Built: 2019  
Construction: Concrete / Metal  
Furnished: No  
Occupied: No  
Floor Area Total: 534 sq. Ft.

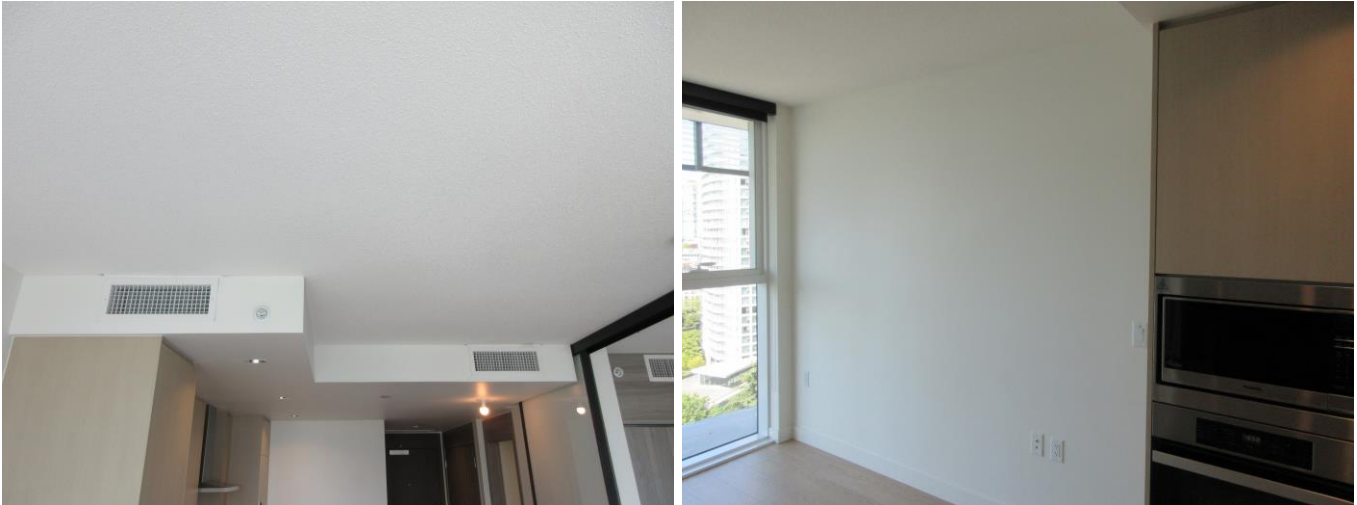
The house had the concrete floor, dry board ceiling and metal framing walls. The interior walls, ceilings, and floors show no defects or structural deficiencies at the time of this home inspection.

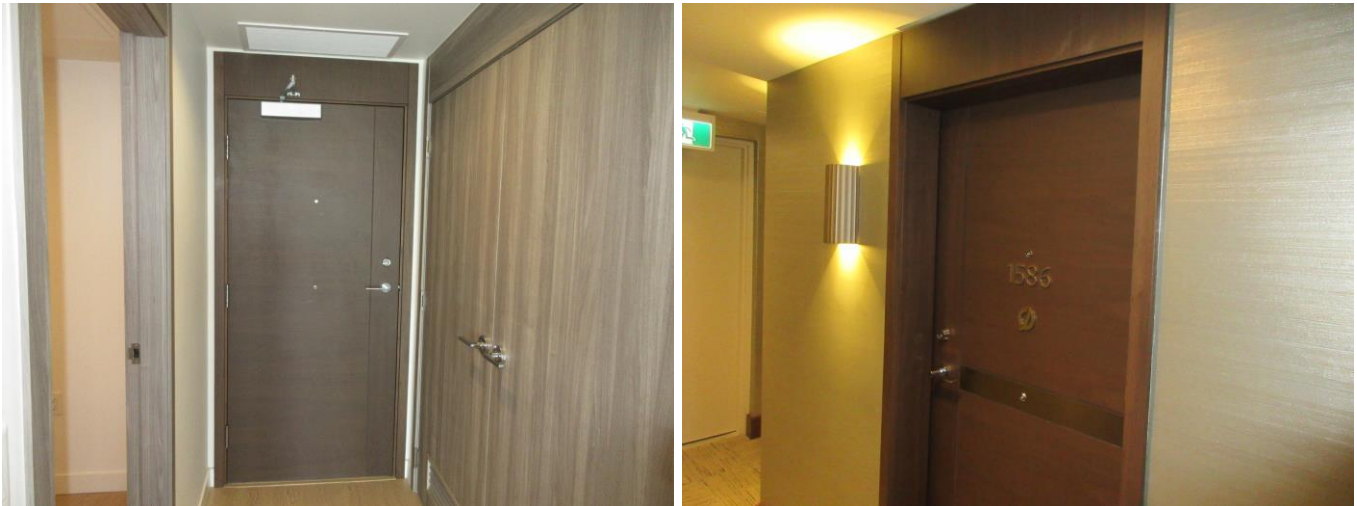
The house had wood type main entrance door. The main entrance door of the house seems to functioning with no deficiency at the time of this home inspection. The interior doors, closet doors, and hardware were functioning and likely perfect with no deficiency at the time of this home inspection.

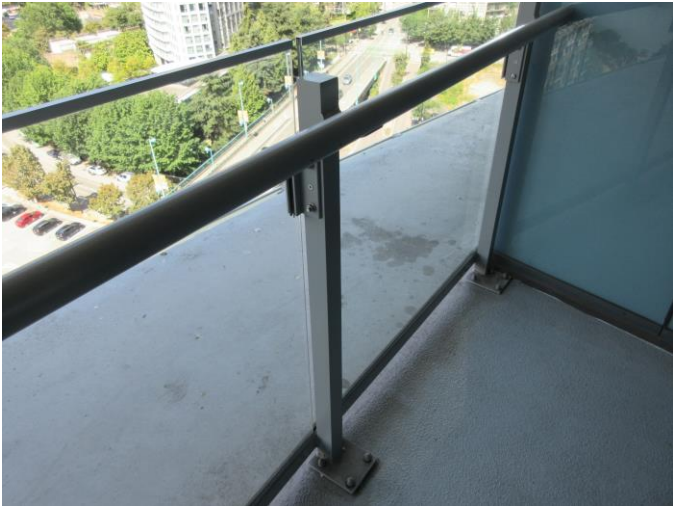
The house had glass / metal guard for the balcony. The handrail and guard of the balcony were functional with no deficiency at the time of this home inspection.

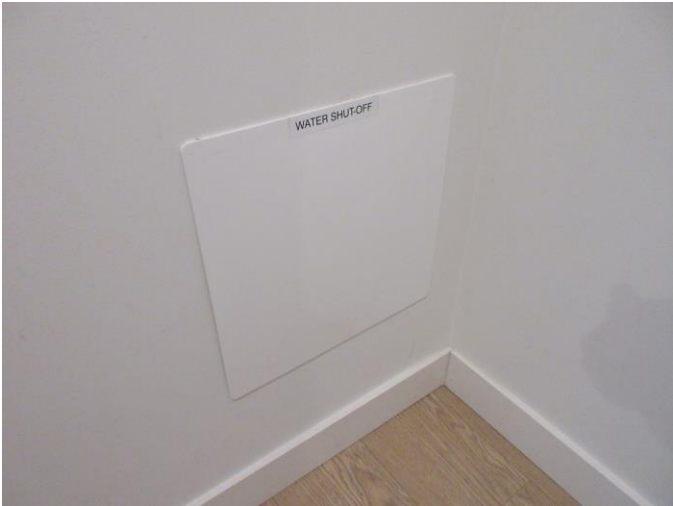
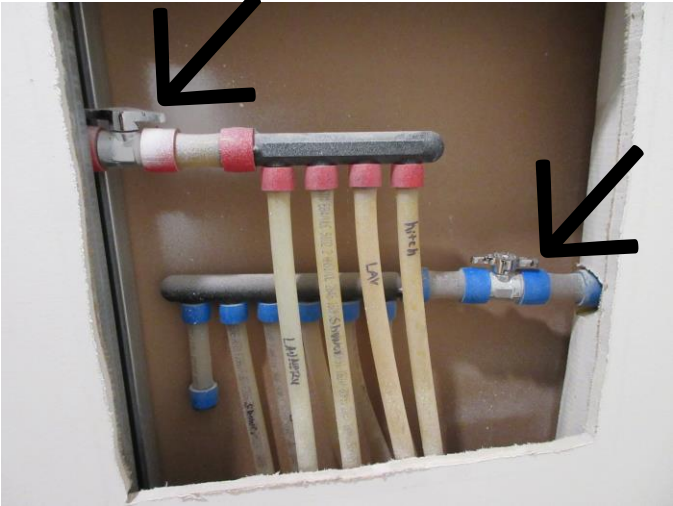
The house original supply pipes was uponor PEX. It was functional with no deficiency at the time of this home inspection. The life expectancy of PEX piping is 40-50 years. The main water shut off valve is located in the den room of the house.

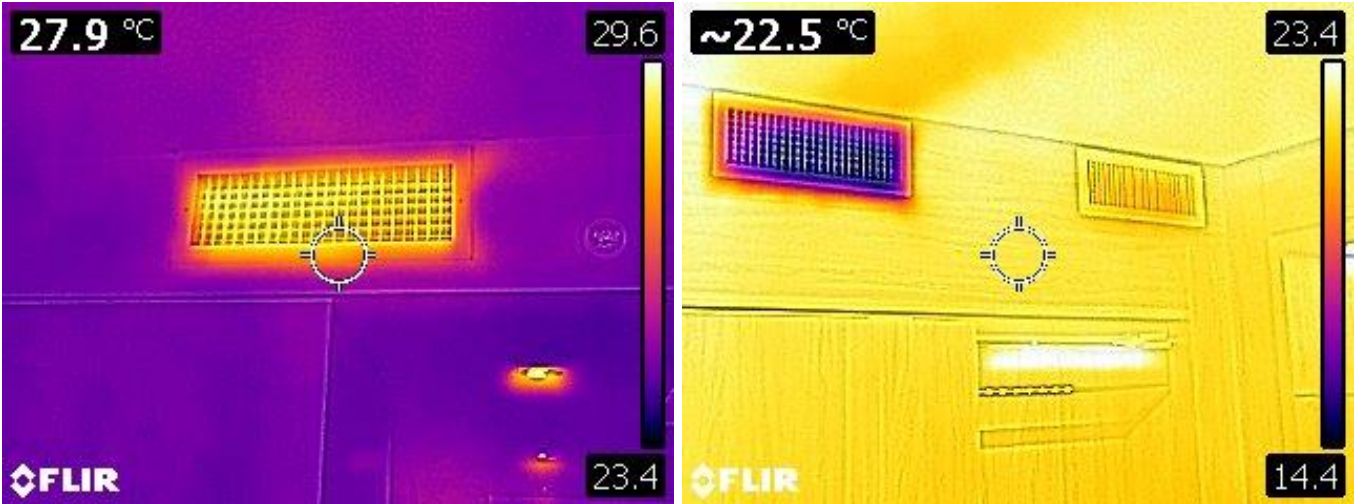
The house had fan coil unit connected to central heating system. The fan coil unit was tested. The fan coil unit was functional with no deficiency at the time of this home inspection.

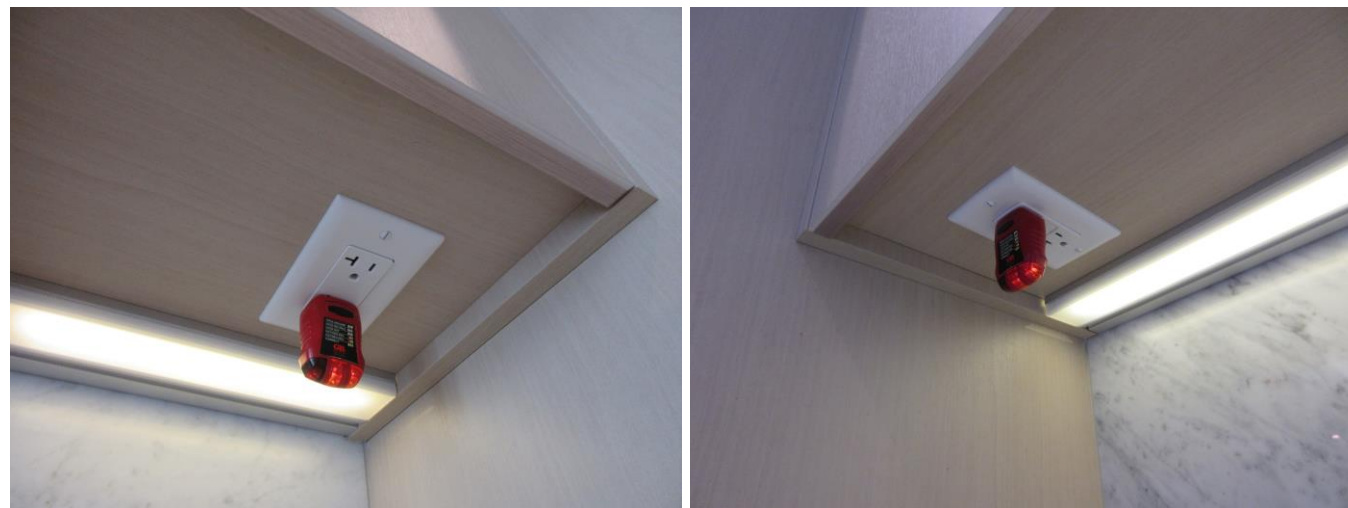
There were GFCI-type outlets in the house kitchen. GFCI outlets were tested and appeared to be in serviceable condition on this home inspection day.

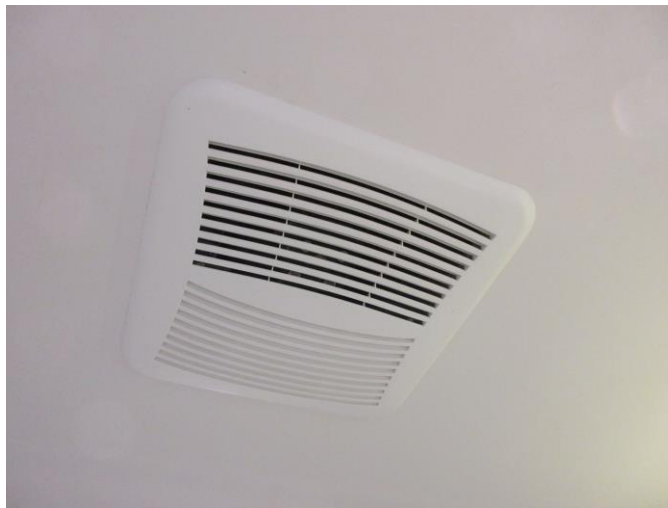
There was electrical exhaust fans in the bathroom of the house. The exhaust fan in the bathroom was tested and functional with no deficiency at the time of this home inspection.

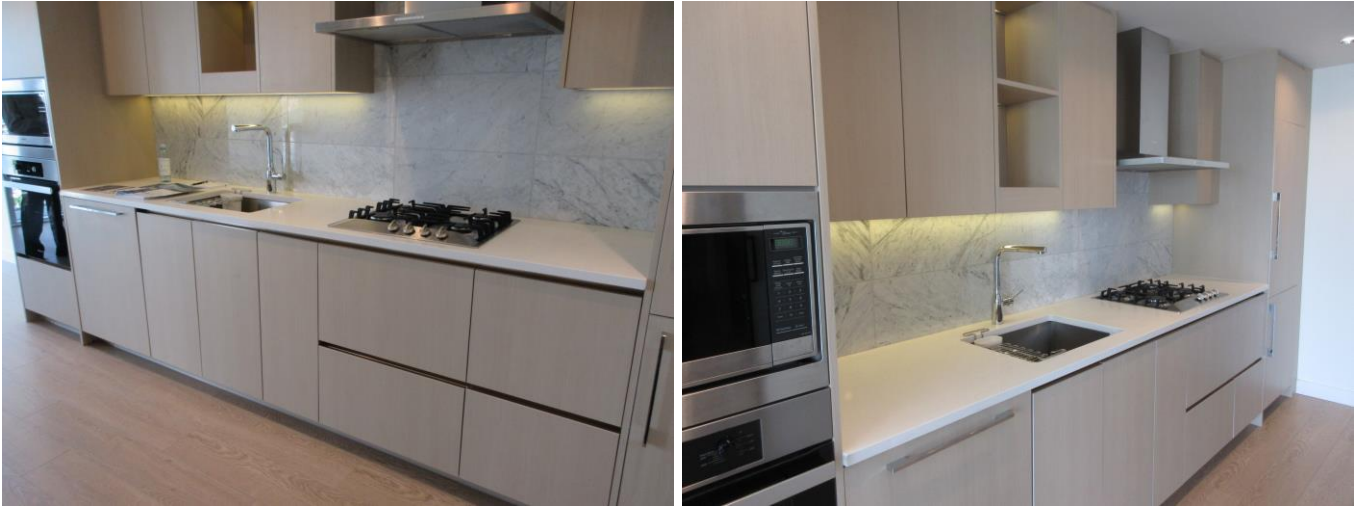
The house had quartz countertop type with MDF type for cabinet door. The cabinet and counter of the kitchen were functional with no deficiency in the house at this home inspection.

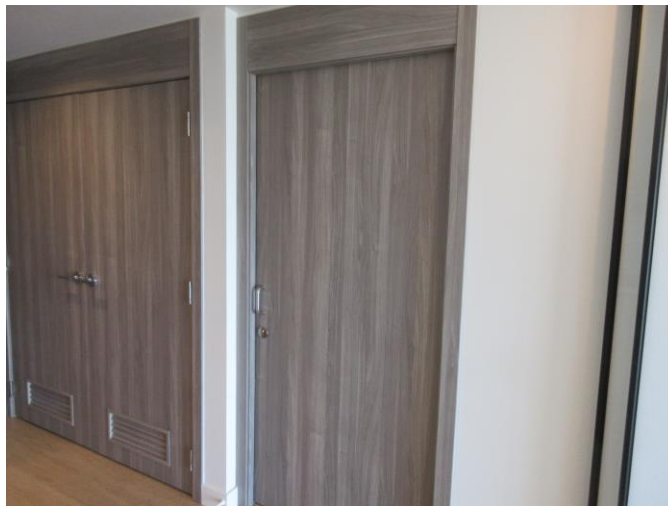
The house had MDF door type for rooms and closet door. The interior doors, closet doors, and hardware were functioning and likely perfect with no deficiency at the time of this home inspection.

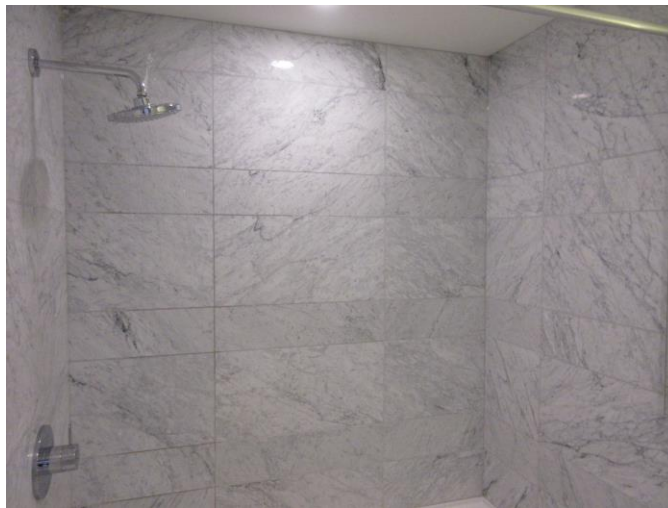
The bathroom shower wall tiles and grout looks prefect with no deficiency at the time of this home inspection.

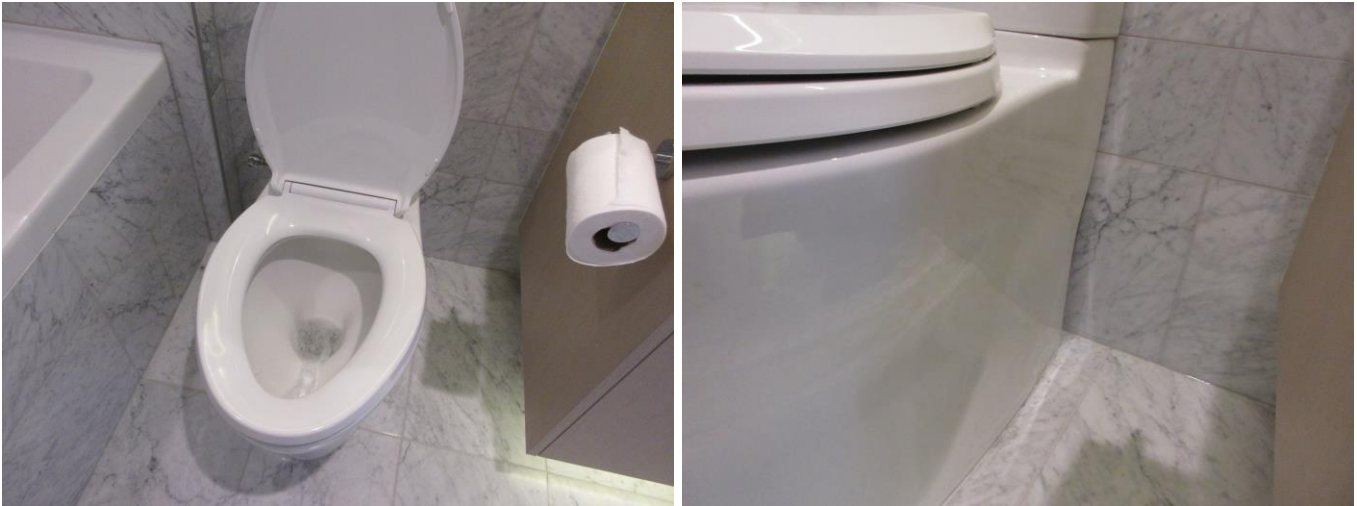
The toilets was tested in the house. It was functional and appropriately installed with no deficiency at the time of this home inspection. No movement, cracks or leaks to the flush tanks or toilets.

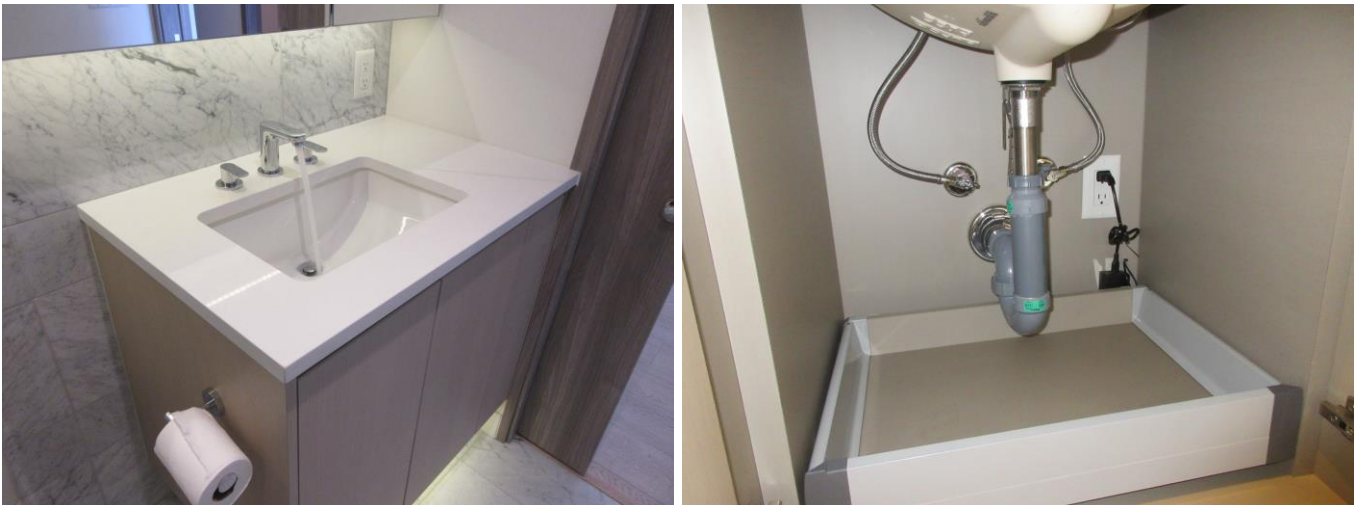
The basin and faucet was tested in the bathroom of the house. The basin bowl was secure and faucet was functioning with no deficiency and at the time of this home inspection. The faucet seemed to be in satisfactory condition at the time of this home inspection. The water pressure and drainage seem adequate.

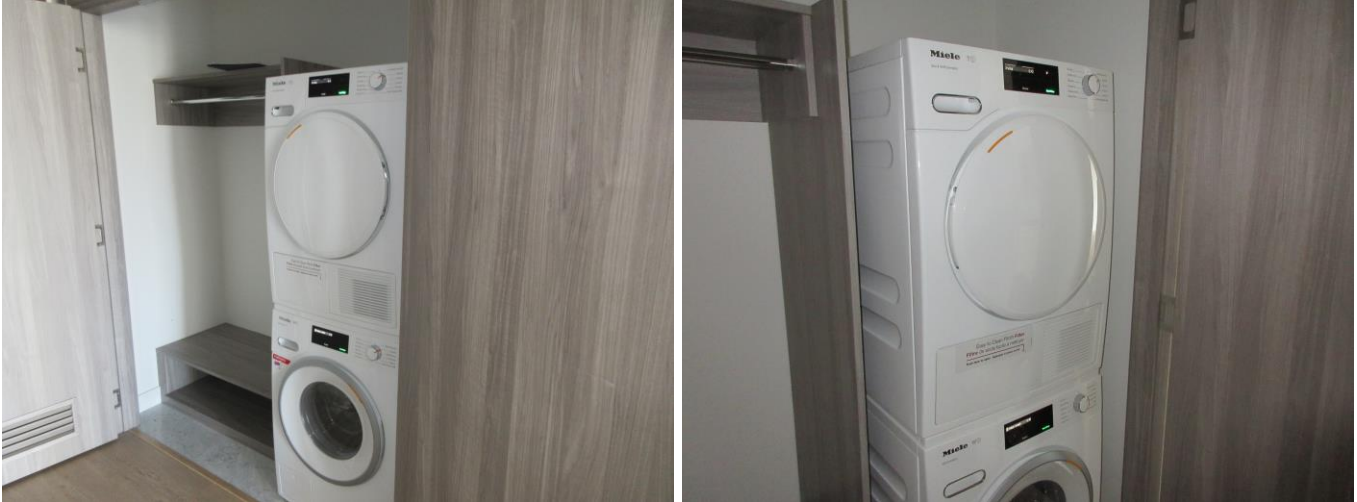
The washing machine and dryer were tested in the laundry room. There was no water leakage for washing machine. The washer and dryer were both functioning at the time of this home inspection.

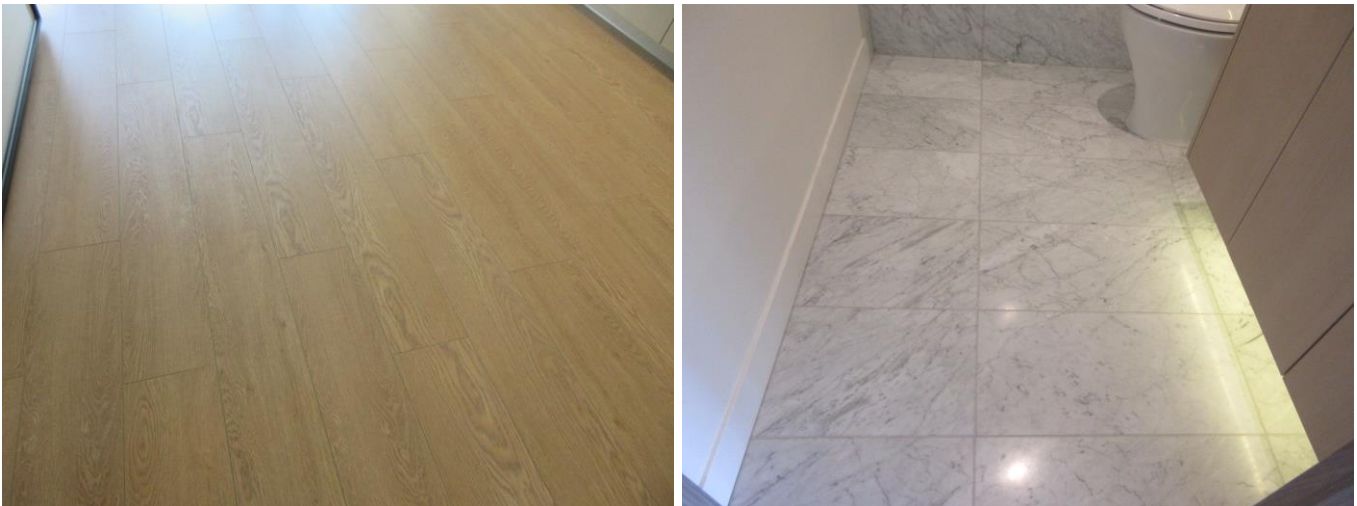
The house floor was covered by laminate, and stone. It was likely perfect with no deficiency at the time of this home inspection.

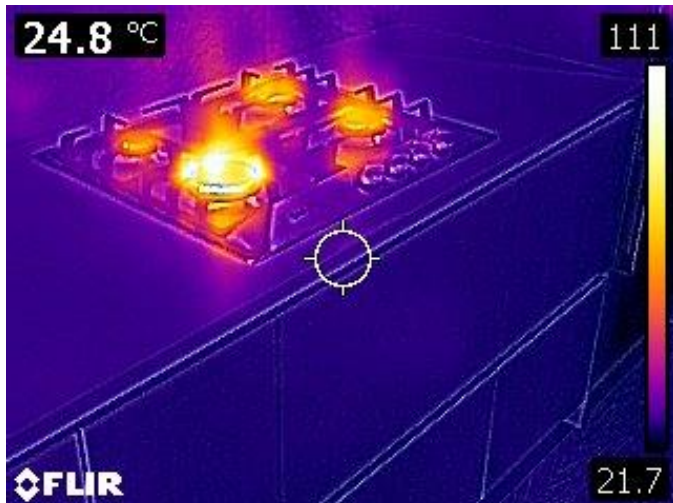
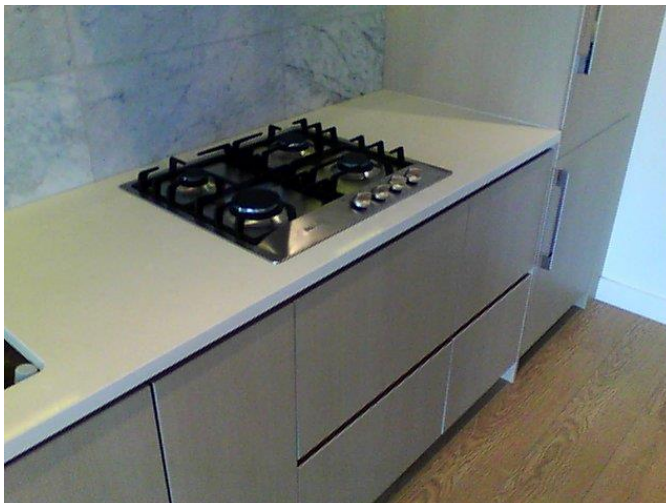
The house had gas burning range type. The gas range was tested. The range was functional without deficiency at the time of this home inspection.

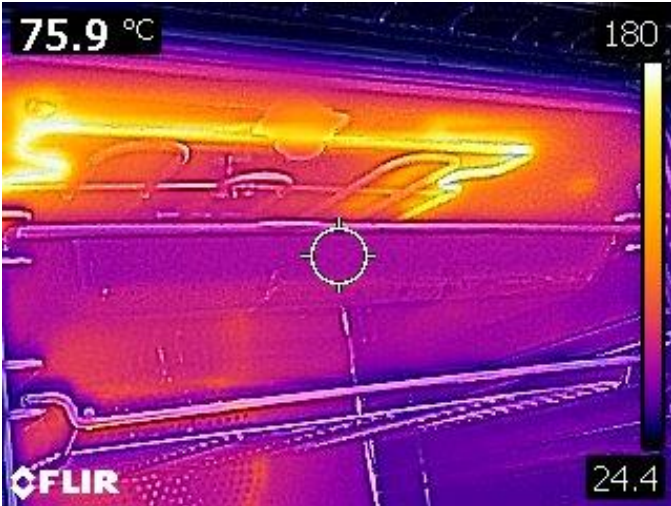
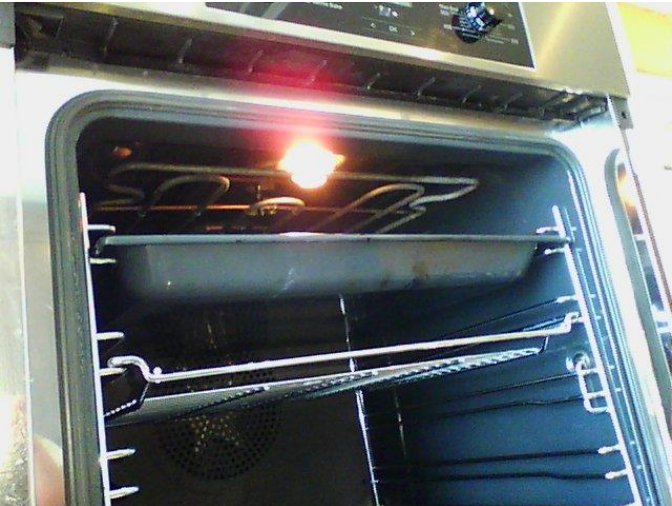
The house had electrical gas oven type. The oven was tested and was functional at the time of this home inspection.
